Access Compliance Report

Public Rights-of-Way

(Curb Ramps)

Intersection ID: 45629	Main Street: SARDIS_RD_NORTH	Cross Street: GALLERIA_BV	Location: SW
ADA ID: B76C97146B50	Ramp Type: Combination1Diag	Initial Pass/Fail: Fail	Overall Compliance: No
		Severity Score: 0

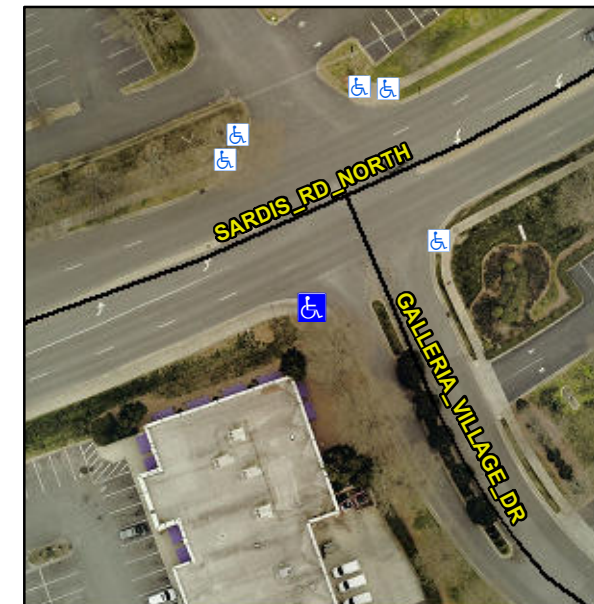
LT RP < 5%

Not Found, R304.5.1, R304.5.1, R304.2.2, R304.5.3

Compliance	Description	Data	Compliance	Description	Data
N/A	Ramp Length LT (in)	59.0	N/A	Ramp Length RT (in)	54.5
No	Ramp Width LT (in)	39.0	No	Ramp Width RT (in)	38.5
Yes	Ramp Slope LT (%)	3.6	Yes	Ramp Slope RT (%)	7.0
No	Ramp XSlope LT (%)	2.8	No	Ramp XSlope RT (%)	2.8
N/A	Ramp Length (in)	35.0	No	Ramp Slope (%)	8.4
No	Ramp Width (in)	42.0	No	Ramp XSlope (%)	2.8
N/A	Flare Type LT	N/A	N/A	Flare Type RT	N/A
N/A	Flare Slope LT (%)	N/A	N/A	Flare Slope RT (%)	N/A
N/A	Flare Traversable LT?	N/A	N/A	Flare Traversable RT?	N/A
N/A	Landing Length (in)	N/A	N/A	DWS Provided?	N/A
N/A	Landing Width (in)	N/A	N/A	DWS Contrast?	N/A
N/A	Landing Slope (%)	N/A	N/A	DWS Length (in)	N/A
N/A	Landing X Slope (%)	N/A	N/A	DWS Full Width?	N/A
N/A	Landing Curb? (Y/N)	N/A	N/A	DWS Offset (in)	N/A
N/A	Shared Landing?	N/A			
N/A	Gutter Ponding?	N/A	N/A	Gutter Slope (%)	N/A
N/A	Gutter Lip Ht (in)	N/A	N/A	Gutter X Slope (%)	N/A
N/A	Painted X Walk1?	No	N/A	Painted X Walk2?	No

X Walk 1 Direction	To NE		X Walk 2 Direction	To NW
	X Walk 1 Width (in)	N/A		X Walk 2 Width (in)	N/A
	X Walk 1 Slope (%)	0.8		X Walk 2 Slope (%)	0.7
	X Walk 1 X Slope (%)	0.5		X Walk 2 X Slope (%)	1.8
N/A	Ramp inside XWalk1?	N/A	N/A	Ramp inside XWalk2?	N/A
	Road Slope (%)	3.0		Clear Space?	N/A
	Road X Slope (%)	3.7	N/A	Clear Space to XWalk (in)	N/A
			N/A	Any Obstruction?	N/A
				Obstruction Type	N/A
			N/A	Storm Grate/Utility Hazard?	N/A
				Storm Grate/Utility Type	N/A
					N/A
Yes	Surface Condition? (G/P)	Good			
	Curb Slope (%)	5.2

Remove & Replace Curb Ramp With Two New Directional Ramps or Equivalent.
