# Access Compliance Report

## Public Rights-of-Way

### (Curb Ramps)

Intersection ID: 10040928	Main Street: WALLACE_RD	Cross Street: N/A	Location: SW
ADA ID: B7724CFDD4AE	Ramp Type: PerpDiag	Initial Pass/Fail: Fail	Overall Compliance: No
Severity Score: 33.75			
Codes/Mitigation Info/Possible Solution		Field Measurements/Component Compliance

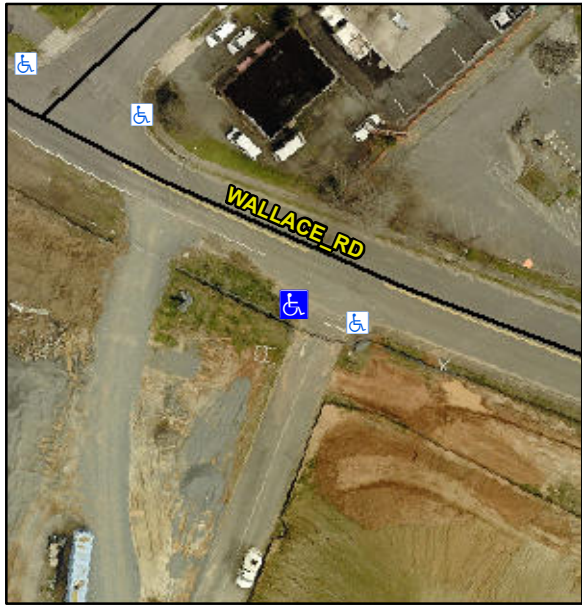
Compliance	Description	Data	Compliance	Description	Data
N/A	Ramp Length (in)	48.0	No	Ramp Slope (%)	14.9
No	Ramp Width (in)	45.0	Yes	Ramp XSlope (%)	1.0
N/A	Flare Type LT	N/A	N/A	Flare Type RT	N/A
N/A	Flare Slope LT (%)	N/A	N/A	Flare Slope RT (%)	N/A
N/A	Flare Traversable LT?	N/A	N/A	Flare Traversable RT?	N/A
N/A	Landing Length (in)	N/A	N/A	DWS Provided?	N/A
N/A	Landing Width (in)	N/A	N/A	DWS Contrast?	N/A
N/A	Landing Slope (%)	N/A	N/A	DWS Length (in)	N/A
N/A	Landing X Slope (%)	N/A	N/A	DWS Full Width?	N/A
N/A	Landing Curb? (Y/N)	N/A	N/A	DWS Offset (in)	N/A
N/A	Shared Landing?	N/A			
N/A	Gutter Ponding?	N/A	N/A	Gutter Slope (%)	N/A
N/A	Gutter Lip Ht (in)	N/A	N/A	Gutter X Slope (%)	N/A
N/A	Painted X Walk1?	No	N/A	Painted X Walk2?	No
	X Walk 1 Direction	To E		X Walk 2 Direction	To N
N/A	X Walk 1 Width (in)	N/A	N/A	X Walk 2 Width (in)	N/A
	X Walk 1 Slope (%)	1.4		X Walk 2 Slope (%)	3.3
	X Walk 1 X Slope (%)	2.2		X Walk 2 X Slope (%)	0.6

N/A	Ramp inside XWalk1?	N/A	N/A	Ramp inside XWalk2?	N/A
	Road Slope (%)	2.0	N/A	Clear Space?	N/A
	Road X Slope (%)	1.3	N/A	Clear Space to XWalk (in)	N/A
N/A	Any Obstructions?	N/A	N/A	Storm Grate/Utility Hazard?	N/A
	Obstruction Type			Storm Grate/Utility Type	
		N/A			N/A
			Yes	Surface Condition? (G/P)	Good

Remove & Replace Curb Ramp With Two New Directional Ramps or Equivalent.

Not Found, R304.5.1, R304.2.2

\$3200.00
