## **Access Compliance Report Public Rights-of-Way** (Curb Ramps)

Main Street: CASTLE WATCH AV **Cross Street: N/A** Location: Intersection ID: 10022821 NW **ADA ID: B774DB1AFBCC** Ramp Type: PerpDiag Initial Pass/Fail: Fail **Overall Compliance: No** Severity Score: 36.25

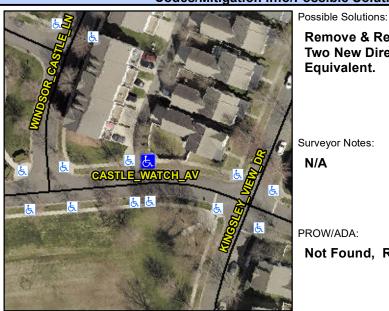
Not Found, R304.5.1, R304.5.3

N/A	Ramp Length (In)	127.0	Yes	Ramp Slope (%)
No	Ramp Width (in)	26.0	No	Ramp XSlope (%)
N/A	Flare Type LT	N/A	N/A	Flare Type RT
N/A	Flare Slope LT (%)	N/A	N/A	Flare Slope RT (%)
N/A	Flare Traversable LT?	N/A	N/A	Flare Traversable RT?
N/A	Landing Length (in)	N/A	N/A	DWS Provided?
N/A	Landing Width (in)	N/A	N/A	DWS Contrast?
N/A	Landing Slope (%)	N/A	N/A	DWS Length (in)
N/A	Landing X Slope (%)	N/A	N/A	DWS Full Width?
N/A	Landing Curb? (Y/N)	N/A	N/A	DWS Offset (in)
N/A	Shared Landing?	N/A		
N/A	Gutter Ponding?	N/A	N/A	Gutter Slope (%)
N/A	Gutter Lip Ht (in)	N/A	N/A	Gutter X Slope (%)
N/A	Painted X Walk1?	No	N/A	Painted X Walk2?
	X Walk 1 Direction	To W		X Walk 2 Direction
N/A	X Walk 1 Width (in)	N/A	N/A	X Walk 2 Width (in)
	X Walk 1 Slope (%)	0.2		X Walk 2 Slope (%)
	X Walk 1 X Slope (%)	3.5		X Walk 2 X Slope (%)
N/A	Ramp inside XWalk1?	N/A	N/A	Ramp inside XWalk2?
	Road Slope (%)	1.2	N/A	Clear Space?
	Road X Slope (%)	3.2	N/A	Clear Space to XWalk (in)

N/A Street 1 Name Stop Condition-Street 2 None Street 2 Name **CASTLE WATCH AV** Stop Condition-Street 1 None Remove & Replace Curb Ramp With Two New Directional Ramps or Equivalent.
