Access Compliance Report

Public Rights-of-Way

(Curb Ramps)

Intersection ID: 14003	Main Street: MT_VERNON_AV	Cross Street: MYRTLE_AV	Location: NW
ADA ID: B782F8F275B8	Ramp Type: Directional1	Initial Pass/Fail: Fail	Overall Compliance: No
		Severity Score: 1.25

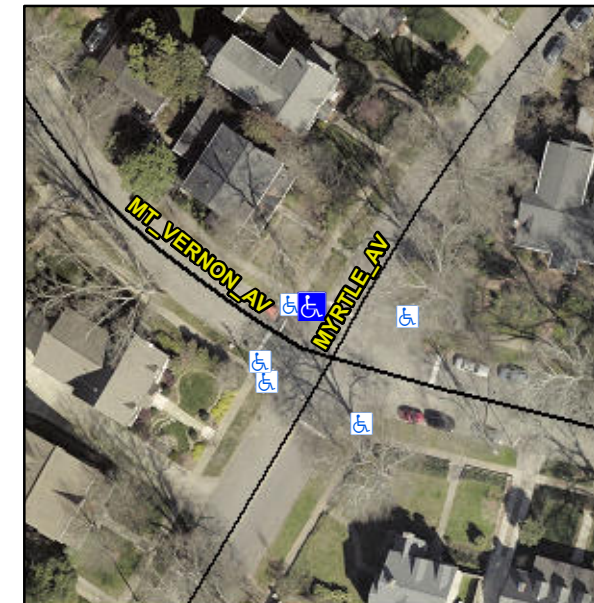
Compliance	Description	Data	Compliance	Description	Data
N/A	Ramp Length (in)	52.0	N/A	Grade Break?	N/A
Yes	Ramp Width (in)	48.0	N/A	Grade Break Slope (%)	0.0
Yes	Ramp Slope (%)	5.3	N/A	Grade Break XSlope (%)	0.0
No	Ramp XSlope (%)	4.3			
N/A	Flare Type LT	N/A	N/A	Flare Type RT	N/A
N/A	Flare Slope LT (%)	N/A	N/A	Flare Slope RT (%)	0.0
N/A	Flare Traversable LT?	N/A	N/A	Flare Traversable RT?	N/A
N/A	Landing Length (in)	0.0	N/A	DWS Provided?	N/A
N/A	Landing Width (in)	0.0	N/A	DWS Contrast?	N/A
N/A	Landing Slope (%)	0.0	N/A	DWS Length (in)	N/A
N/A	Landing X Slope (%)	0.0	N/A	DWS Full Width?	N/A
N/A	Landing Curb? (Y/N)	N/A	N/A	DWS Offset LT (in)	N/A
N/A	Shared Landing?	N/A	N/A	DWS Offset RT (in)	N/A
N/A	Gutter Ponding?	0.0	N/A	Gutter Slope (%)	N/A
N/A	Gutter Lip Ht (in)	1.0	N/A	Gutter X Slope (%)	N/A
N/A	Painted X Walk1?	No		Road Slope (%)	0.1
	X Walk 1 Direction	To E		Road X Slope (%)	5.0
	X Walk 1 Width (in)	N/A		Clear Space?	N/A

X Walk 1 Slope (%)	0.1	N/A	Clear Space to XWalk (in)	N/A
	X Walk 1 X Slope (%)	5.0	N/A	Storm Grate/Utility Hazard?	N/A
N/A	Ramp inside XWalk1?	N/A		Storm Grate/Utility Type	
N/A	Any Obstructions?	N/A			N/A
	Obstruction Type		Yes	Surface Condition? (G/P)	Good
			N/A	Curb Slope (%)	10.0

Possible Solutions:

Remove & Replace Entire Ramp.

R304.5.3

Total Cost: \$ 1600.00
