## Access Compliance Report Public Rights-of-Way (Curb Ramps)

Intersection ID: 44064 Main Street: SEDGEMOOR\_LN Cross Street: LONGSTONE\_LN Location: N

ADA ID: B7995617F745 Ramp Type: BlendTrans1 Initial Pass/Fail: Fail Overall Compliance: No Severity Score: 35

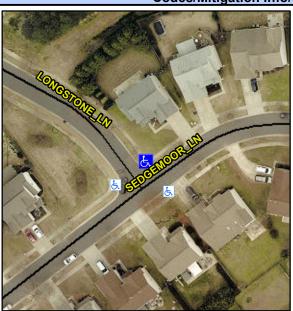
Field Measure	ements/C	ompo	nent Compliance	
	Compliance Description		Data	Compliance Description		Data
	N/A	Ramp Length (in)	70.0	Yes	BlendTrans Slope (%)	1.5
	No	Ramp Width (in)	25.0	Yes	BlendTrans XSlope (%)	1.7
	N/A	Flare Type LT	N/A	N/A	Flare Type RT	N/A
	N/A	Flare Slope LT (%)	N/A	N/A	Flare Slope RT (%)	N/A
	N/A	Flare Traversable LT?	N/A	N/A	Flare Traversable RT?	N/A
	N/A	Landing Length (in)	N/A	N/A	DWS Provided?	N/A
	N/A	Landing Width (in)	N/A	N/A	DWS Contrast?	N/A
	N/A	Landing Slope (%)	N/A	N/A	DWS Length (in)	N/A
	N/A	Landing X Slope (%)	N/A	N/A	DWS Full Width?	N/A
	N/A	Landing Curb? (Y/N)	N/A	N/A	DWS Offset (in)	N/A
	N/A	Shared Landing?	N/A			
	N/A	Gutter Ponding?	N/A	N/A	Gutter Slope (%)	N/A
	N/A	Gutter Lip Ht (in)	N/A	N/A	Gutter X Slope (%)	N/A
	N/A	Painted X Walk1?	No	N/A	Painted X Walk2?	No
		X Walk 1 Direction	To SW		X Walk 2 Direction	To SE
		X Walk 1 Width (in)	N/A		X Walk 2 Width (in)	N/A

X Walk 1 Slope (%)	2.0		X Walk 2 Slope (%)	1.2
		X Walk 1 X Slope (%)	1.4		X Walk 2 X Slope (%)	1.5
	N/A	Ramp inside XWalk1?	N/A	N/A	Ramp inside XWalk2?	N/A
		Road Slope (%)	0.9		Clear Space?	N/A
		Road X Slope (%)	3.0	N/A	Clear Space to XWalk (in)	N/A
	N/A	Any Obstructions?	N/A	N/A	Storm Grate/Utility Hazard?	N/A
		Obstruction Type			Storm Grate/Utility Type	
			N/A		,	N/A
				Yes	Surface Condition? (G/P)	Good

Remove & Replace Curb Ramp With Two New Directional Ramps or Equivalent.

R304.5.1

Total Cost: \$ 3200.00
