## **Access Compliance Report Public Rights-of-Way** (Curb Ramps)

Intersection ID: 32121 Main Street: ALEXA RD **Cross Street: PROVIDENCE\_RD** Location: SE **ADA ID: B7B47A3C6DB7** Ramp Type: PerpDiag Initial Pass/Fail: Fail **Overall Compliance: No Severity Score:** 22.5

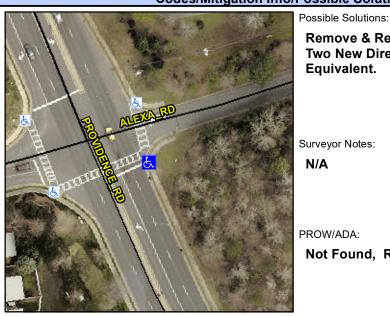
Field Measurements/Component Compnance								
Compliance Description		Data	Comp	Data				
	N/A	Ramp Length (in)	83.0	No	Ramp Slope (%)	9.1		
	No	Ramp Width (in)	39.0	Yes	Ramp XSlope (%)	2.2		
	N/A	Flare Type LT	N/A	N/A	Flare Type RT	N/A		
	N/A	Flare Slope LT (%)	N/A	N/A	Flare Slope RT (%)	N/A		
	N/A	Flare Traversable LT?	N/A	N/A	Flare Traversable RT?	N/A		
	N/A	Landing Length (in)	N/A	N/A	DWS Provided?	N/A		
	N/A	Landing Width (in)	N/A	N/A	DWS Contrast?	N/A		
	N/A	Landing Slope (%)	N/A	N/A	DWS Length (in)	N/A		
	N/A	Landing X Slope (%)	N/A	N/A	DWS Full Width?	N/A		
	N/A	Landing Curb? (Y/N)	N/A	N/A	DWS Offset (in)	N/A		
	N/A	Shared Landing?	N/A					
	N/A	Gutter Ponding?	N/A	N/A	Gutter Slope (%)	N/A		
	N/A	Gutter Lip Ht (in)	N/A	N/A	Gutter X Slope (%)	N/A		
	N/A	Painted X Walk1?	No	N/A	Painted X Walk2?	No		
		X Walk 1 Direction	To N		X Walk 2 Direction	To W		
	N/A	X Walk 1 Width (in)	N/A	N/A	X Walk 2 Width (in)	N/A

X Walk 1 Slope (%)	1.5		X Walk 2 Slope (%)	9.7		
		X Walk 1 X Slope (%)	8.7		X Walk 2 X Slope (%)	1.5		
	N/A	Ramp inside XWalk1?	N/A	N/A	Ramp inside XWalk2?	N/A		
		Road Slope (%)	4.6	N/A	Clear Space?	N/A		
		Road X Slope (%)	9.9	N/A	Clear Space to XWalk (in)	N/A		
	N/A	Any Obstructions?	N/A	N/A	Storm Grate/Utility Hazard?	N/A		
		Obstruction Type			Storm Grate/Utility Type			
			N/A			N/A		
				Yes	Surface Condition? (G/P)	Good

Possible Solutions:	Complian	
Remove & Replace Curb Ramp With	N/A	F
Two New Directional Ramps or	No	R
Equivalent.	N/A	F
	N/A	F
	N/A	F
	N/A	L
Surveyor Notes:	N/A	L
N/A	N/A	L
	N/A	L
	N/A	L
	N/A	S
PROW/ADA:	N/A	(
Not Found, R304.5.1, R304.2.2	N/A	C
	N/A	F
		Х
	N/A	Х
		Х
		Х
	N/A	F
		F
		-

Total Cost: 3200.00
