Access Compliance Report

Public Rights-of-Way

(Curb Ramps)

Intersection ID: 4199	Main Street: OLD_STATESVILLE_RD	Cross Street: W_W_T_HARRIS_BV	Location: SW
ADA ID: B7C7919A8AC2	Ramp Type: Perp	Initial Pass/Fail: Fail	Overall Compliance: No Severity Score: 21.25

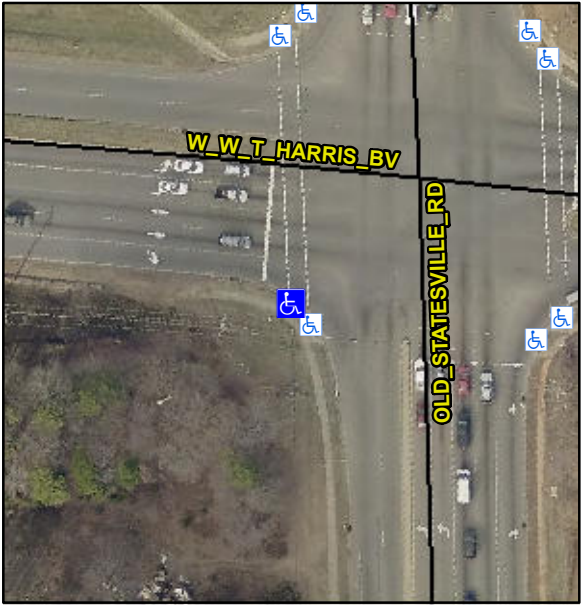
Possible Solutions:		Compliance	Description	Data
	Remove & Replace Entire Ramp.		No	Ramp Length (in)	59.5
			No	Ramp Width (in)	47.0
			N/A	Flare Type LT	N/A
			N/A	Flare Slope LT (%)	N/A
			N/A	Flare Traversable LT?	N/A
			N/A	Landing Length (in)	N/A
			N/A	Landing Width (in)	N/A
			N/A	Landing Slope (%)	N/A
			N/A	Landing X Slope (%)	N/A
<p>Surveyor Notes:</p> <p>N/A</p> <p>PROW/ADA:</p> <p>Not Found, R304.5.1, R304.2.2</p>			N/A	Flare Type RT	N/A
			N/A	Flare Slope RT (%)	N/A
			N/A	Flare Traversable RT?	N/A
			N/A	DWS Provided?	N/A
			N/A	DWS Contrast?	N/A
			N/A	DWS Length (in)	N/A
			N/A	DWS Full Width?	N/A
			N/A	DWS Offset (in)	N/A
			N/A	Gutter Ponding?	N/A
			N/A	Gutter Lip Ht (in)	N/A
			N/A	Painted X Walk1?	Yes
				X Walk 1 Direction	To N
			N/A	X Walk 1 Width (in)	96.0
				X Walk 1 Slope (%)	0.8
				X Walk 1 X Slope (%)	0.0
