Access Compliance Report

Public Rights-of-Way

(Curb Ramps)

Intersection ID: 31463	Main Street: COBDEN_LN	Cross Street: HARLAND_ST	Location: S
ADA ID: B7D0E7F5BBEF	Ramp Type: BlendTrans2	Initial Pass/Fail: Pass	Overall Compliance: No
Severity Score: 0			
Codes/Mitigation Info/Possible Solution		Field Measurements/Component Compliance

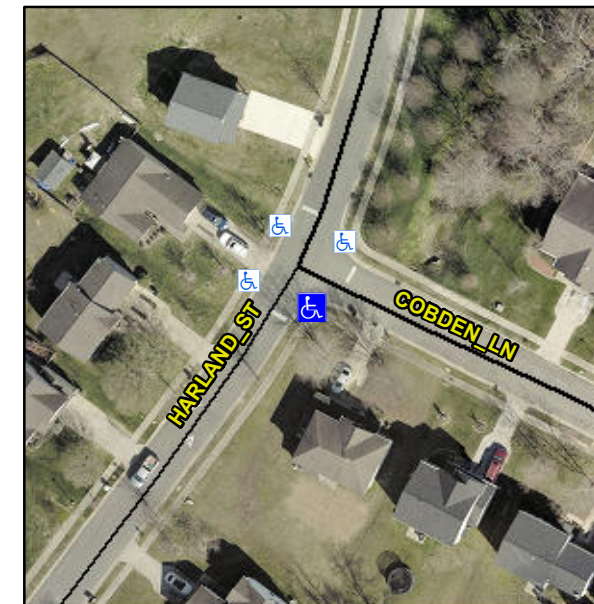
Not Found, R305.2, R304.5.3

Compliance	Description	Data	Compliance	Description	Data
N/A	Ramp Length (in)	97.0	Yes	BlendTrans Slope (%)	3.5
Yes	Ramp Width (in)	48.0	Yes	BlendTrans XSlope (%)	0.8
N/A	Flare Type LT	None	N/A	Flare Type RT	None
N/A	Flare Slope LT (%)	N/A	N/A	Flare Slope RT (%)	N/A
N/A	Flare Traversable LT?	N/A	N/A	Flare Traversable RT?	N/A
N/A	Landing Length (in)	N/A	Yes	DWS Provided?	Yes
N/A	Landing Width (in)	N/A	Yes	DWS Contrast?	Yes
N/A	Landing Slope (%)	N/A	Yes	DWS Length (in)	24.0
N/A	Landing X Slope (%)	N/A	Yes	DWS Full Width?	Yes
N/A	Landing Curb? (Y/N)	No	No	DWS Offset (in)	7.0
N/A	Shared Landing?	No			
Yes	Gutter Ponding?	No	Yes	Gutter Slope (%)	3.2
Yes	Gutter Lip Ht (in)	0.0	No	Gutter X Slope (%)	3.9
N/A	Painted X Walk1?	No	N/A	Painted X Walk2?	No
	X Walk 1 Direction	To NE		X Walk 2 Direction	To NW
	X Walk 1 Width (in)	N/A		X Walk 2 Width (in)	N/A
	X Walk 1 Slope (%)	2.3		X Walk 2 Slope (%)	4.1
	X Walk 1 X Slope (%)	2.3		X Walk 2 X Slope (%)	3.0

N/A	Ramp inside XWalk1?	N/A	N/A	Ramp inside XWalk2?	N/A
	Road Slope (%)	0.9		Clear Space?	Yes
	Road X Slope (%)	4.2	N/A	Clear Space to XWalk (in)	N/A
Yes	Any Obstructions?	No	Yes	Storm Grate/Utility Hazard?	No
	Obstruction Type			Storm Grate/Utility Type	
		N/A			N/A
			Yes	Surface Condition? (G/P)	Good
			No	Curb Slope (%)	21.4

Remove & Replace Curb Ramp With Two New Directional Ramps or Equivalent. Remove & Replace Gutter.

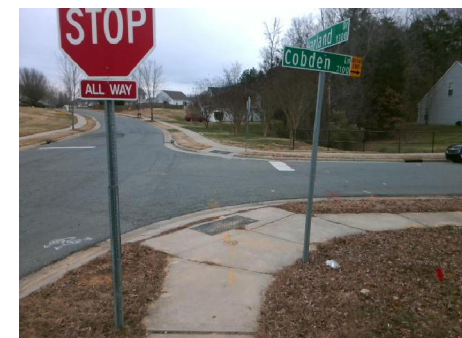
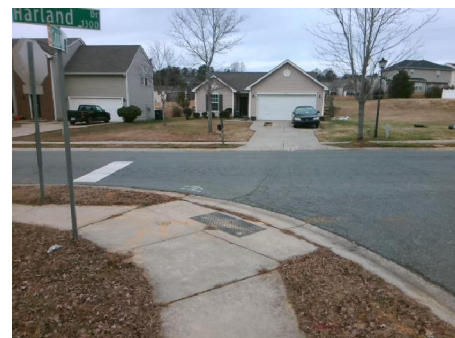
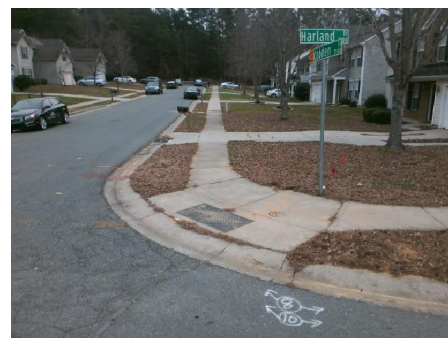
Street 1 Name COBDEN LN
 Stop Condition-Street 1 StopSign
 Street 2 Name HARLAND ST
 Stop Condition-Street 2 StopSign
