Access Compliance Report

Public Rights-of-Way

(Curb Ramps)

Intersection ID: 12020	Main Street: E_W_T_HARRIS_BV	Cross Street: TANTILLA_CR	Location: SW
ADA ID: B7DA83F605A2	Ramp Type: PerpDiag	Initial Pass/Fail: Fail	Overall Compliance: No
Severity Score: 13.75			
Codes/Mitigation Info/Possible Solution		Field Measurements/Component Compliance

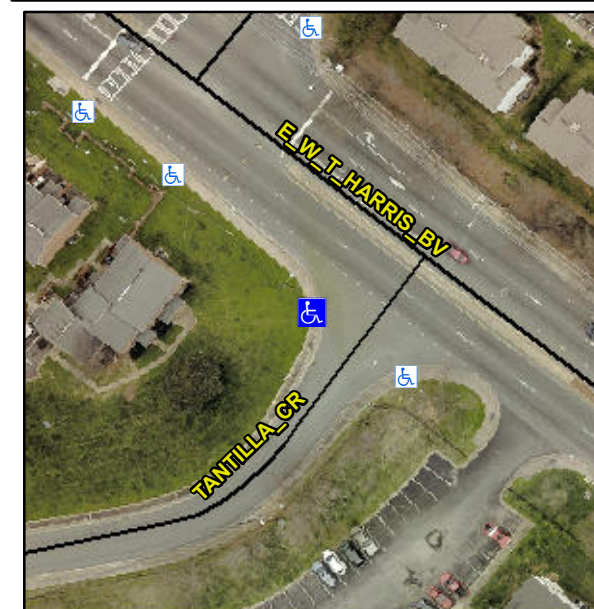
Not Found, R304.2.2, R304.5.3

Compliance	Description	Data	Compliance	Description	Data
N/A	Ramp Length (in)	59.0	No	Ramp Slope (%)	9.1
Yes	Ramp Width (in)	48.0	No	Ramp XSlope (%)	2.2
N/A	Flare Type LT	N/A	N/A	Flare Type RT	N/A
N/A	Flare Slope LT (%)	N/A	N/A	Flare Slope RT (%)	N/A
N/A	Flare Traversable LT?	N/A	N/A	Flare Traversable RT?	N/A
N/A	Landing Length (in)	N/A	N/A	DWS Provided?	N/A
N/A	Landing Width (in)	N/A	N/A	DWS Contrast?	N/A
N/A	Landing Slope (%)	N/A	N/A	DWS Length (in)	N/A
N/A	Landing X Slope (%)	N/A	N/A	DWS Full Width?	N/A
N/A	Landing Curb? (Y/N)	N/A	N/A	DWS Offset (in)	N/A
N/A	Shared Landing?	N/A			
N/A	Gutter Ponding?	N/A	N/A	Gutter Slope (%)	N/A
N/A	Gutter Lip Ht (in)	1.0	N/A	Gutter X Slope (%)	N/A
N/A	Painted X Walk1?	No	N/A	Painted X Walk2?	No
	X Walk 1 Direction	To SE		X Walk 2 Direction	To NE
N/A	X Walk 1 Width (in)	N/A	N/A	X Walk 2 Width (in)	N/A
	X Walk 1 Slope (%)	2.0		X Walk 2 Slope (%)	4.4
	X Walk 1 X Slope (%)	4.6		X Walk 2 X Slope (%)	0.5

N/A	Ramp inside XWalk1?	N/A	N/A	Ramp inside XWalk2?	N/A
	Road Slope (%)	2.0	N/A	Clear Space?	N/A
	Road X Slope (%)	5.8	N/A	Clear Space to XWalk (in)	N/A
N/A	Any Obstructions?	N/A	N/A	Storm Grate/Utility Hazard?	N/A
	Obstruction Type			Storm Grate/Utility Type	
		N/A			N/A
		Yes		Surface Condition? (G/P)	Good

Remove & Replace Curb Ramp With Two New Directional Ramps or Equivalent.

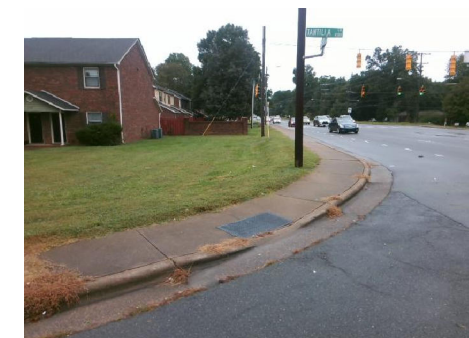
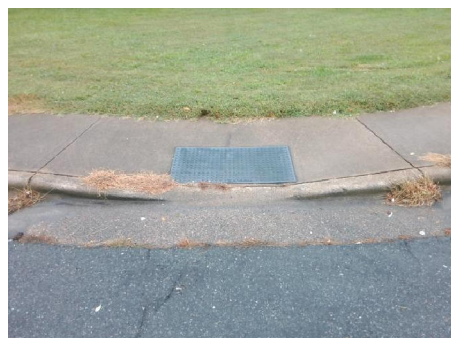
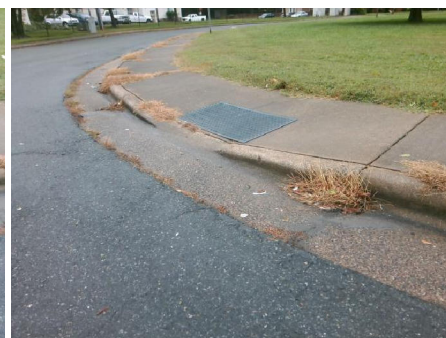
Street 1 Name TANTILLA CR
 Stop Condition-Street 2 StopSign
 Street 2 Name E W T HARRIS BV
 Stop Condition-Street 1 None
