# Access Compliance Report

## Public Rights-of-Way

### (Curb Ramps)

Intersection ID: 22027	Main Street: CAMBRIDGE CRESCENT DR	Cross Street: CARMEL CRESCENT DR	Location: S
ADA ID: B7DBFD407759	Ramp Type: PerpDiag	Initial Pass/Fail: Fail	Overall Compliance: No
		Severity Score: 12.5

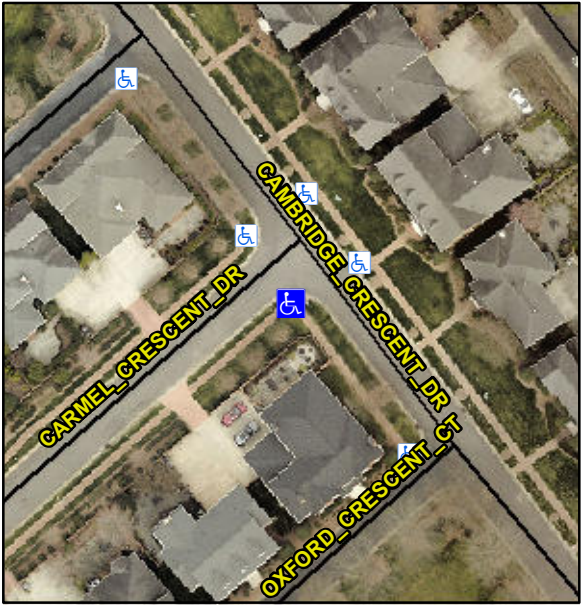
Possible Solutions:		<b>Compliance</b>	<b>Description</b>	<b>Data</b>
	<b>Remove &amp; Replace Curb Ramp With Two New Directional Ramps or Equivalent.</b>		<b>Yes</b>	Ramp Length (in)	<b>68.0</b>
			<b>N/A</b>	Ramp Width (in)	<b>48.0</b>
			<b>N/A</b>	Flare Type LT	<b>N/A</b>
			<b>N/A</b>	Flare Slope LT (%)	<b>N/A</b>
			<b>N/A</b>	Flare Traversable LT?	<b>N/A</b>
			<b>N/A</b>	Landing Length (in)	<b>N/A</b>
			<b>N/A</b>	Landing Width (in)	<b>N/A</b>
			<b>N/A</b>	Landing Slope (%)	<b>N/A</b>
			<b>N/A</b>	Landing X Slope (%)	<b>N/A</b>
<p>Surveyor Notes:</p> <p><b>N/A</b></p> <p>PROW/ADA:</p> <p><b>R304.5.3</b></p>			<b>N/A</b>	Flare Type RT	<b>N/A</b>
			<b>N/A</b>	Flare Slope RT (%)	<b>N/A</b>
			<b>N/A</b>	Flare Traversable RT?	<b>N/A</b>
			<b>N/A</b>	DWS Provided?	<b>N/A</b>
			<b>N/A</b>	DWS Contrast?	<b>N/A</b>

<b>N/A</b>	DWS Length (in)	<b>N/A</b>
			<b>N/A</b>	DWS Full Width?	<b>N/A</b>
			<b>N/A</b>	DWS Offset (in)	<b>N/A</b>
			<b>N/A</b>	Gutter Ponding?	<b>N/A</b>
			<b>N/A</b>	Gutter Lip Ht (in)	<b>N/A</b>
			<b>N/A</b>	Painted X Walk1?	<b>No</b>
				X Walk 1 Direction	<b>To NE</b>
			<b>N/A</b>	X Walk 1 Width (in)	<b>N/A</b>
				X Walk 1 Slope (%)	<b>0.5</b>
				X Walk 1 X Slope (%)	<b>3.7</b>
			<b>N/A</b>	Ramp inside XWalk1?	<b>N/A</b>
				Road Slope (%)	<b>4.2</b>
				Road X Slope (%)	<b>2.6</b>
			<b>N/A</b>	Any Obstructions?	<b>N/A</b>
				Obstruction Type	
Total Cost: \$ 3200.00			<b>N/A</b>	Storm Grate/Utility Hazard?	<b>N/A</b>
				Storm Grate/Utility Type	
			<b>N/A</b>		<b>N/A</b>
			<b>Yes</b>	Surface Condition? (G/P)	<b>Good</b>
