Access Compliance Report

Public Rights-of-Way

(Curb Ramps)

Intersection ID: 10023065	Main Street: CHALKSTONE_RD	Cross Street: N/A	Location: SW
ADA ID: B7E6B1AEBDBC	Ramp Type: PerpDiag	Initial Pass/Fail: Fail	Overall Compliance: No
		Severity Score: 10

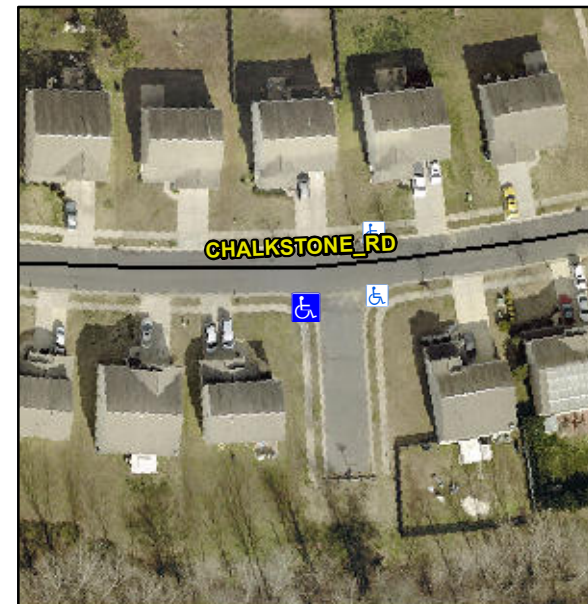
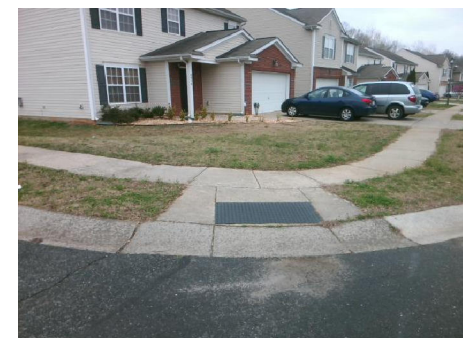
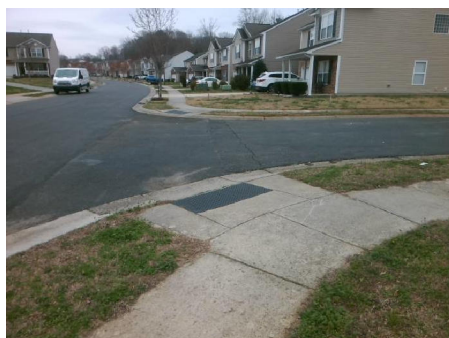
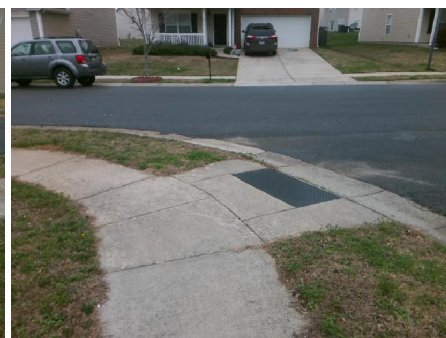
Not Found, R304.5.1, R304.5.3

Compliance	Description	Data	Compliance	Description	Data
N/A	Ramp Length (in)	50.0	Yes	Ramp Slope (%)	6.0
No	Ramp Width (in)	46.0	No	Ramp XSlope (%)	3.5
N/A	Flare Type LT	N/A	N/A	Flare Type RT	N/A
N/A	Flare Slope LT (%)	N/A	N/A	Flare Slope RT (%)	N/A
N/A	Flare Traversable LT?	N/A	N/A	Flare Traversable RT?	N/A
N/A	Landing Length (in)	N/A	N/A	DWS Provided?	N/A
N/A	Landing Width (in)	N/A	N/A	DWS Contrast?	N/A
N/A	Landing Slope (%)	N/A	N/A	DWS Length (in)	N/A
N/A	Landing X Slope (%)	N/A	N/A	DWS Full Width?	N/A
N/A	Landing Curb? (Y/N)	N/A	N/A	DWS Offset (in)	N/A
N/A	Shared Landing?	N/A			
N/A	Gutter Ponding?	N/A	N/A	Gutter Slope (%)	N/A
N/A	Gutter Lip Ht (in)	N/A	N/A	Gutter X Slope (%)	N/A
N/A	Painted X Walk1?	No	N/A	Painted X Walk2?	No
	X Walk 1 Direction	To E		X Walk 2 Direction	To N
N/A	X Walk 1 Width (in)	N/A	N/A	X Walk 2 Width (in)	N/A
	X Walk 1 Slope (%)	0.5		X Walk 2 Slope (%)	3.9
	X Walk 1 X Slope (%)	4.2		X Walk 2 X Slope (%)	1.5

N/A	Ramp inside XWalk1?	N/A	N/A	Ramp inside XWalk2?	N/A
	Road Slope (%)	1.5	N/A	Clear Space?	N/A
	Road X Slope (%)	3.8	N/A	Clear Space to XWalk (in)	N/A
N/A	Any Obstructions?	N/A	N/A	Storm Grate/Utility Hazard?	N/A
	Obstruction Type			Storm Grate/Utility Type	
		N/A			N/A
			Yes	Surface Condition? (G/P)	Good

Remove & Replace Curb Ramp With Two New Directional Ramps or Equivalent.
