| Intersection ID: 24164 | Main Street: COMPTON_CT | Cross Street: PRESCOTT_POND_LN | Location: | SE |
| ADA ID: B7EA185C3D0B | Ramp Type: PerpDiag | Initial Pass/Fail: Fail | Overall Compliance: No | Severity Score: 12.5 |

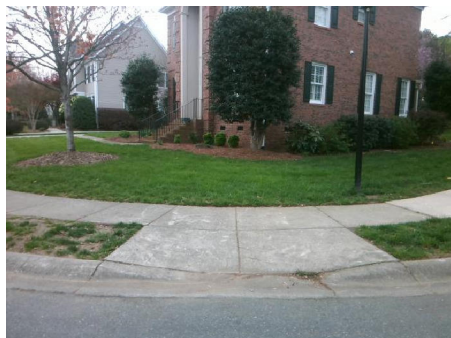
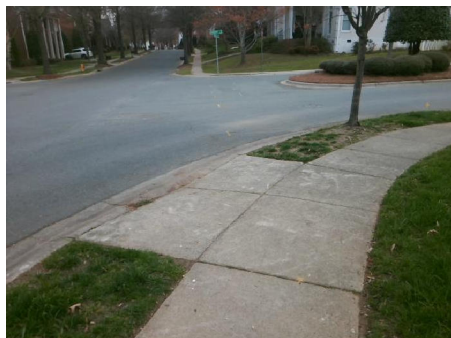
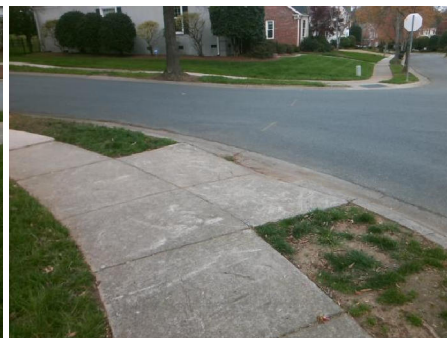
**Not Found, R304.2.2**

| Compliance | Description | Data | Compliance | Description | Data |
|---|---|---|---|---|---|
| N/A | Ramp Length (in) | 47.0 | No | Ramp Slope (%) | 11.1 |

**Remove & Replace Curb Ramp With Two New Directional Ramps or Equivalent.**
