# Access Compliance Report

## Public Rights-of-Way

### (Curb Ramps)

Intersection ID: 10146	Main Street: TUCKASEEGEE_RD	Cross Street: YAHTZEE_LN	Location: NW
ADA ID: B7F3D85BC3F8	Ramp Type: Perp	Initial Pass/Fail: Fail	Overall Compliance: No
Severity Score: 21.25			
Codes/Mitigation Info/Possible Solution		Field Measurements/Component Compliance

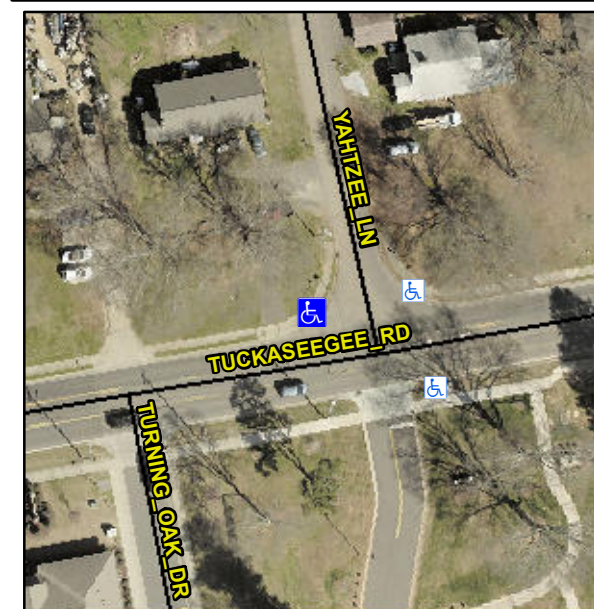
**Not Found, R304.5.1, R304.2.2**

Compliance	Description	Data	Compliance	Description	Data
N/A	Ramp Length (in)	84.0	No	Ramp Slope (%)	8.7
No	Ramp Width (in)	39.0	Yes	Ramp XSlope (%)	0.2
N/A	Flare Type LT	N/A	N/A	Flare Type RT	N/A
N/A	Flare Slope LT (%)	N/A	N/A	Flare Slope RT (%)	N/A
N/A	Flare Traversable LT?	N/A	N/A	Flare Traversable RT?	N/A
N/A	Landing Length (in)	N/A	N/A	DWS Provided?	N/A
N/A	Landing Width (in)	N/A	N/A	DWS Contrast?	N/A
N/A	Landing Slope (%)	N/A	N/A	DWS Length (in)	N/A
N/A	Landing X Slope (%)	N/A	N/A	DWS Full Width?	N/A
N/A	Landing Curb? (Y/N)	N/A	N/A	DWS Offset (in)	N/A
N/A	Shared Landing?	N/A			
N/A	Gutter Ponding?	Yes	N/A	Gutter Slope (%)	N/A
N/A	Gutter Lip Ht (in)	N/A	N/A	Gutter X Slope (%)	N/A
N/A	Painted X Walk1?	No	N/A	Painted X Walk2?	N/A
	X Walk 1 Direction	To E		X Walk 2 Direction	N/A
N/A	X Walk 1 Width (in)	N/A	N/A	X Walk 2 Width (in)	N/A
	X Walk 1 Slope (%)	3.0		X Walk 2 Slope (%)	N/A
	X Walk 1 X Slope (%)	0.7		X Walk 2 X Slope (%)	N/A

N/A	Ramp inside XWalk1?	N/A	N/A	Ramp inside XWalk2?	N/A
	Road Slope (%)	N/A	N/A	Clear Space?	N/A
	Road X Slope (%)	N/A	N/A	Clear Space to XWalk (in)	N/A
N/A	Any Obstructions?	N/A	N/A	Storm Grate/Utility Hazard?	N/A
	Obstruction Type			Storm Grate/Utility Type	
		N/A			N/A
			Yes	Surface Condition? (G/P)	Good

**Remove & Replace Entire Ramp.**

Total Cost: \$ 1850.00
