# Access Compliance Report

## Public Rights-of-Way

### (Curb Ramps)

Intersection ID: 10447	Main Street: SYLVANIA_AV	Cross Street: BANCROFT_ST	Location: NW
ADA ID: B7F52698DDAE	Ramp Type: Perp	Initial Pass/Fail: Fail	Overall Compliance: No
		Severity Score: 8.75

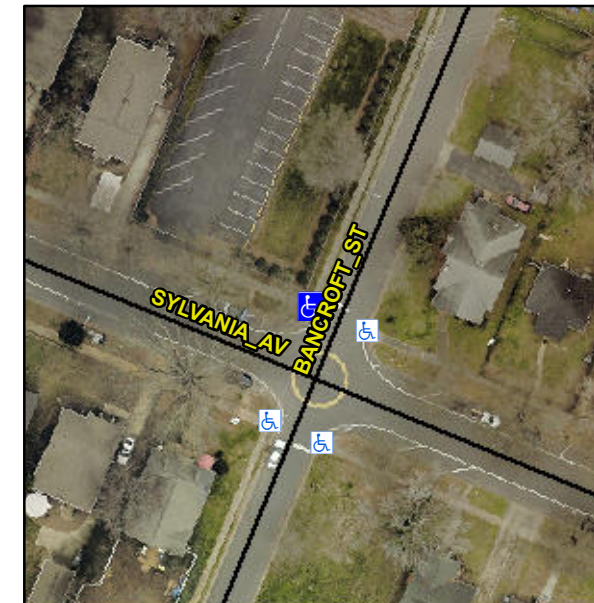
**Not Found, R304.5.1**

Compliance	Description	Data	Compliance	Description	Data
N/A	Ramp Length (in)	62.0	Yes	Ramp Slope (%)	8.0
No	Ramp Width (in)	42.0	Yes	Ramp XSlope (%)	1.7
N/A	Flare Type LT	N/A	N/A	Flare Type RT	N/A
N/A	Flare Slope LT (%)	N/A	N/A	Flare Slope RT (%)	N/A
N/A	Flare Traversable LT?	N/A	N/A	Flare Traversable RT?	N/A
N/A	Landing Length (in)	N/A	N/A	DWS Provided?	N/A
N/A	Landing Width (in)	N/A	N/A	DWS Contrast?	N/A
N/A	Landing Slope (%)	N/A	N/A	DWS Length (in)	N/A
N/A	Landing X Slope (%)	N/A	N/A	DWS Full Width?	N/A
N/A	Landing Curb? (Y/N)	N/A	N/A	DWS Offset (in)	N/A
N/A	Shared Landing?	N/A			
N/A	Gutter Ponding?	N/A	N/A	Gutter Slope (%)	N/A
N/A	Gutter Lip Ht (in)	0.5	N/A	Gutter X Slope (%)	N/A
N/A	Painted X Walk1?	No	N/A	Painted X Walk2?	N/A
	X Walk 1 Direction	To SE		X Walk 2 Direction	N/A
N/A	X Walk 1 Width (in)	N/A	N/A	X Walk 2 Width (in)	N/A
	X Walk 1 Slope (%)	1.6		X Walk 2 Slope (%)	N/A
	X Walk 1 X Slope (%)	1.1		X Walk 2 X Slope (%)	N/A

N/A	Ramp inside XWalk1?	N/A	N/A	Ramp inside XWalk2?	N/A
	Road Slope (%)	N/A	N/A	Clear Space?	N/A
	Road X Slope (%)	N/A	N/A	Clear Space to XWalk (in)	N/A
N/A	Any Obstructions?	N/A	N/A	Storm Grate/Utility Hazard?	N/A
	Obstruction Type			Storm Grate/Utility Type	
		N/A			N/A
			Yes	Surface Condition? (G/P)	Good

**Remove & Replace Entire Ramp.**

Total Cost: \$ 1850.00
