Access Compliance Report Public Rights-of-Way (Curb Ramps)

Intersection ID: 26468 Main Street: BEVINGTON_PL Cross Street: REA_RD Location: NW

Overall Compliance: No ADA ID: B7FBE7E2F21F Ramp Type: Perp Initial Pass/Fail: Fail Severity Score: 33.75

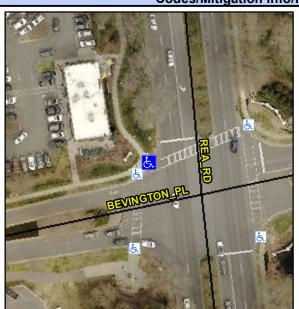
Field Measurements/Component Compliance								
Compl	liance Description	Data	Compl	iance	Description	Data		
N/A	Ramp Length (in)	72.0	No	Ramp	Slope (%)	8.7		
No	Ramp Width (in)	46.0	No Ramp XSlope (%)		6.2			
N/A	Flare Type LT	N/A	N/A Flare Type RT		N/A			
N/A	Flare Slope LT (%)	N/A	N/A Flare Slope RT (%)		N/A			
N/A	Flare Traversable LT?	N/A	N/A	Flare	Traversable RT?	N/A		
N/A	Landing Length (in)	N/A	N/A	DWS	Provided?	N/A		
N/A	Landing Width (in)	N/A	N/A	DWS	Contrast?	N/A		
N/A	Landing Slope (%)	N/A	N/A	DWS	Length (in)	N/A		
N/A	Landing X Slope (%)	N/A	N/A	DWS	Full Width?	N/A		
N/A	Landing Curb? (Y/N)	N/A	N/A	DWS	Offset (in)	N/A		
N/A	Shared Landing?	N/A						
N/A	Gutter Ponding?	N/A	N/A	Gutte	r Slope (%)	N/A		
N/A	Gutter Lip Ht (in)	N/A	N/A	Gutte	r X Slope (%)	N/A		
N/A	Painted X Walk1?	Yes	N/A	Paint	ed X Walk2?	N/A		
	X Walk 1 Direction	To NE		X Wa	lk 2 Direction	N/A		
N/A	X Walk 1 Width (in)	111.0	N/A	X Wa	lk 2 Width (in)	N/A

X Walk 1 Slope (%)	3.5		X Wa	lk 2 Slope (%)	N/A		
	X Walk 1 X Slope (%)	2.0		X Wa	lk 2 X Slope (%)	N/A		
N/A	Ramp inside XWalk1?	Yes	N/A	Ramp	inside XWalk2?	N/A		
	Road Slope (%)	N/A	N/A	Clear	Space?	N/A		
	Road X Slope (%)	N/A	N/A	Clear	Space to XWalk (in)	N/A		
N/A	Any Obstructions?	N/A	N/A	Storm	n Grate/Utility Hazard?	N/A		
	Obstruction Type			Storm	Grate/Utility Type			
		N/A				N/A		
			Yes	Surfa	ce Condition? (G/P)	Good

Possible Solutions:						
Remove & Replace Entire Ramp.						
•						
Surveyor Notes:						
N/A						
PROW/ADA:						
Not Found, R304.5.1, R304.2.2,						
R304.5.3
