# Access Compliance Report

## Public Rights-of-Way

### (Curb Ramps)

| Intersection ID: 48949 | Main Street: OLD_STONE_CROSSING_DR | Cross Street: DAVID_JENNINGS_AV | Location: SW |

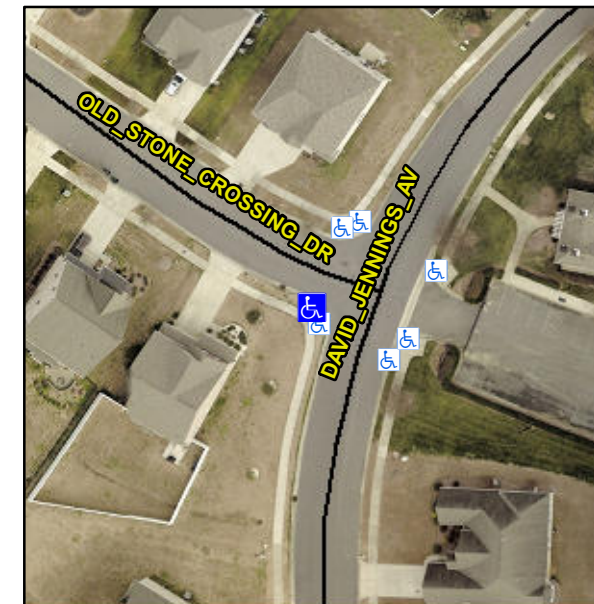
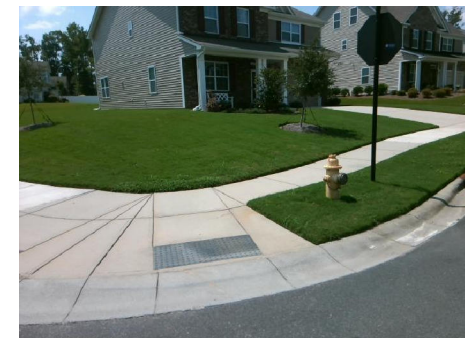
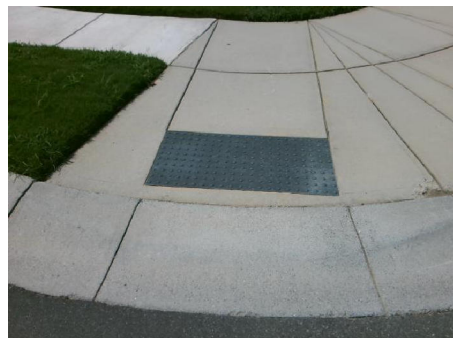
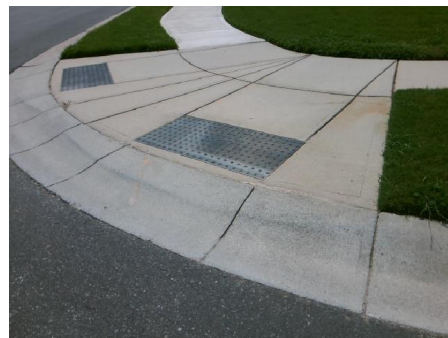
**CURB LIP 0.5**

**Not Found, R304.5.1**

| Compliance | Description | Data | Compliance | Description | Data |
|---|---|---|---|---|---|
| No | Ramp Width (in) | 46.0 | Yes | BlendTrans XSlope (%) | 0.1 |
| | | | No | Curb Slope (%) | 24.5 |

**Remove & Replace Curb Ramp With Two New Directional Ramps or Equivalent.**

Total Cost: \$ 3200.00
