Access Compliance Report

Public Rights-of-Way

(Curb Ramps)

Intersection ID: 23642	Main Street: CASTLEGATE_DR	Cross Street: HEATHERFORD_DR	Location: NE
ADA ID: B80724E1E49A	Ramp Type: Directional1	Initial Pass/Fail: Fail	Overall Compliance: No
		Severity Score: 10

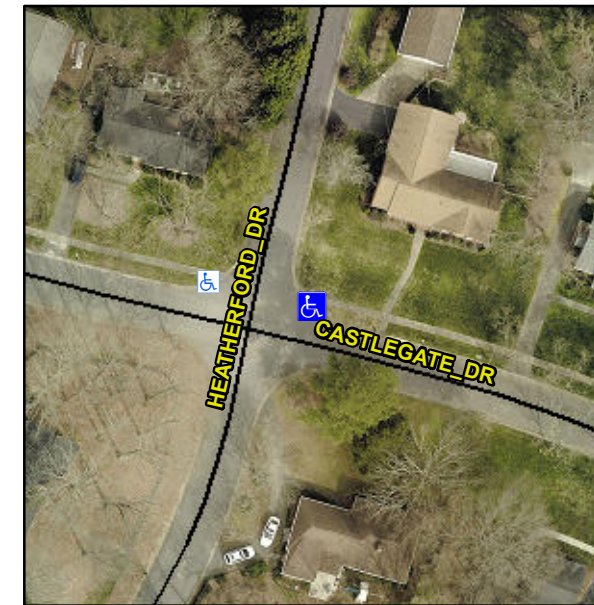
R304.5.1, R304.5.3

Compliance	Description	Data	Compliance	Description	Data
N/A	Ramp Length (in)	28.0	N/A	Grade Break?	N/A
No	Ramp Width (in)	47.5	N/A	Grade Break Slope (%)	0.0
Yes	Ramp Slope (%)	6.3	N/A	Grade Break XSlope (%)	0.0
No	Ramp XSlope (%)	4.2			
N/A	Flare Type LT	N/A	N/A	Flare Type RT	N/A
N/A	Flare Slope LT (%)	N/A	N/A	Flare Slope RT (%)	0.0
N/A	Flare Traversable LT?	N/A	N/A	Flare Traversable RT?	N/A
N/A	Landing Length (in)	0.0	N/A	DWS Provided?	N/A
N/A	Landing Width (in)	0.0	N/A	DWS Contrast?	N/A
N/A	Landing Slope (%)	0.0	N/A	DWS Length (in)	N/A
N/A	Landing X Slope (%)	0.0	N/A	DWS Full Width?	N/A
N/A	Landing Curb? (Y/N)	N/A	N/A	DWS Offset LT (in)	N/A
N/A	Shared Landing?	N/A	N/A	DWS Offset RT (in)	N/A
N/A	Gutter Ponding?	0.0	N/A	Gutter Slope (%)	N/A
N/A	Gutter Lip Ht (in)	0.0	N/A	Gutter X Slope (%)	N/A
N/A	Painted X Walk1?	No		Road Slope (%)	1.5
	X Walk 1 Direction	To W		Road X Slope (%)	3.5
	X Walk 1 Width (in)	N/A		Clear Space?	N/A

X Walk 1 Slope (%)	1.5	N/A	Clear Space to XWalk (in)	N/A
	X Walk 1 X Slope (%)	3.5	N/A	Storm Grate/Utility Hazard?	N/A
N/A	Ramp inside XWalk1?	N/A		Storm Grate/Utility Type	
N/A	Any Obstructions?	N/A			N/A
	Obstruction Type		Yes	Surface Condition? (G/P)	Good
			N/A	Curb Slope (%)	0.7

Remove & Replace Entire Ramp.
