Access Compliance Report Public Rights-of-Way (Curb Ramps)

Intersection ID: 51358	Main Street: PIKE_RD		Cross	Street:	BRENTMOOR_DR	Location:	NE		
ADA ID: B807B4BB2794	Ramp Type: PerpDiag			Initial Pass/Fail: Pass Overall Compliance: No				o Severity Score:	15.25
Codes/Mitigation Info/Possible Solution				Field Measurements/Component Compliance					
		Possible Solutions:		Compliance Description Date			a Compliance Description Data		
		Remove & Replace Curb Ramp V	Nith	N/A	Ramp Length (in)	51.0	Yes	Ramp Slope (%)	5.5
		Two New Directional Ramps or		Yes	Ramp Width (in)	48.0	No	Ramp XSlope (%)	3.5
		Equivalent.		N/A	Flare Type LT	Sloped	N/A	Flare Type RT	N/A
				N/A	Flare Slope LT (%)	4.1	N/A	Flare Slope RT (%)	6.5
				N/A	Flare Traversable LT?	No	N/A	Flare Traversable RT?	No
				Yes	Landing Length (in)	67.0	Yes	DWS Provided?	Yes
		Surveyor Notes:		Yes	Landing Width (in)	48.0	Yes	DWS Contrast?	Yes

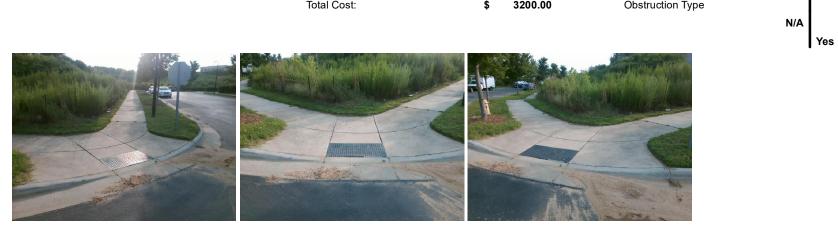
J. C.		N/A		Yes	Landing Slope (%)	1.4	Yes	DWS Length (in)	24.5
	the state of			No	Landing X Slope (%)	4.0	Yes	DWS Full Width?	Yes
E PINE RUD	A solo			N/A	Landing Curb? (Y/N)	No	Yes	DWS Offset (in)	2.0
		6		N/A	Shared Landing?	No			
		PROW/ADA:		No	Gutter Ponding?	Yes	Yes	Gutter Slope (%)	2.5
		Not Found, R304.5.3, R302.7,		No	Gutter Lip Ht (in)	1.0	Yes	Gutter X Slope (%)	1.0
		R302.7.2		N/A	Painted X Walk1?	No	N/A	Painted X Walk2?	No
					X Walk 1 Direction	To W		X Walk 2 Direction	To S
				N/A	X Walk 1 Width (in)	N/A	N/A	X Walk 2 Width (in)	N/A
Street 1 Name	BRENTMOOR DR	-			X Walk 1 Slope (%)	0.2		X Walk 2 Slope (%)	0.5
Stop Condition-Street 2	None				X Walk 1 X Slope (%)	1.2		X Walk 2 X Slope (%)	0.4
Street 2 Name	PIKE RD			N/A	Ramp inside XWalk1?	N/A	N/A	Ramp inside XWalk2?	N/A
Stop Condition-Street 1	StopSign				Road Slope (%)	1.2	N/A	Clear Space?	Yes
					Road X Slope (%)	1.4	N/A	Clear Space to XWalk (in)	N/A

Yes	Any Obstructions?	No	Yes	Storm Grate/Utility Hazard?	No
		Total Cost: \$	3200.00		Obstruction Type			Storm Grate/Utility Type	
						N/A			N/A
