# Access Compliance Report

## Public Rights-of-Way

### (Curb Ramps)

Intersection ID: 52521	Main Street: LORNA_ST	Cross Street: MCCLINTOCK_RD	Location: NW
ADA ID: B80923CBB812	Ramp Type: Perp	Initial Pass/Fail: Pass	Overall Compliance: No
		Severity Score: 15

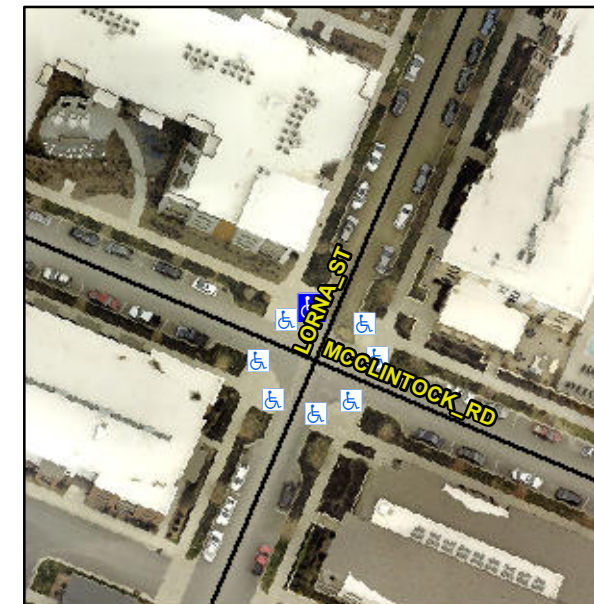
Compliance	Description	Data	Compliance	Description	Data
N/A	Ramp Length (in)	153.0	Yes	Ramp Slope (%)	6.2
Yes	Ramp Width (in)	60.0	Yes	Ramp XSlope (%)	0.5
N/A	Flare Type LT	Sloped	N/A	Flare Type RT	N/A
N/A	Flare Slope LT (%)	9.3	N/A	Flare Slope RT (%)	6.7
N/A	Flare Traversable LT?	Yes	N/A	Flare Traversable RT?	No
Yes	Landing Length (in)	72.0	Yes	DWS Provided?	Yes
Yes	Landing Width (in)	72.0	Yes	DWS Contrast?	Yes
Yes	Landing Slope (%)	1.4	Yes	DWS Length (in)	24.0
Yes	Landing X Slope (%)	1.4	Yes	DWS Full Width?	Yes
N/A	Landing Curb? (Y/N)	No	No	DWS Offset (in)	13.0
N/A	Shared Landing?	Yes			
Yes	Gutter Ponding?	No	Yes	Gutter Slope (%)	4.7
No	Gutter Lip Ht (in)	5.0	Yes	Gutter X Slope (%)	0.6
N/A	Painted X Walk1?	No	N/A	Painted X Walk2?	N/A
	X Walk 1 Direction	To SE		X Walk 2 Direction	N/A
N/A	X Walk 1 Width (in)	N/A	N/A	X Walk 2 Width (in)	N/A
	X Walk 1 Slope (%)	0.5		X Walk 2 Slope (%)	N/A
	X Walk 1 X Slope (%)	0.9		X Walk 2 X Slope (%)	N/A

N/A	Ramp inside XWalk1?	N/A	N/A	Ramp inside XWalk2?	N/A
	Road Slope (%)	N/A	N/A	Clear Space?	Yes
	Road X Slope (%)	N/A	N/A	Clear Space to XWalk (in)	N/A
Yes	Any Obstructions?	No	Yes	Storm Grate/Utility Hazard?	No
	Obstruction Type			Storm Grate/Utility Type	
		N/A			N/A
			Yes	Surface Condition? (G/P)	Good

**Remove & Replace Detectable Warning System. Grind Gutter Lip.**
