Access Compliance Report Public Rights-of-Way (Curb Ramps)

Intersection ID: 42553 Main Street: ESTHER LN **Cross Street: TODDVILLE RD** Location: SW **ADA ID: B81EFA67E3E8** Initial Pass/Fail: Fail **Overall Compliance: No Severity Score:** 1.25 Ramp Type: Perp

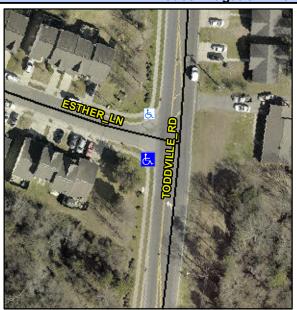
Comp	liance Description	Data	Compl	liance	Description
N/A	Ramp Length (in)	48.0	Yes	Ramp	Slope (%)
Yes	Ramp Width (in)	53.0	No	Ramp	XSlope (%)
N/A	Flare Type LT	N/A	N/A	Flare	Type RT
N/A	Flare Slope LT (%)	N/A	N/A	Flare	Slope RT (%)
N/A	Flare Traversable LT?	N/A	N/A	Flare	Traversable RT?
N/A	Landing Length (in)	N/A	N/A	DWS	Provided?
N/A	Landing Width (in)	N/A	N/A	DWS	Contrast?
N/A	Landing Slope (%)	N/A	N/A	DWS	Length (in)
N/A	Landing X Slope (%)	N/A	N/A	DWS	Full Width?
N/A	Landing Curb? (Y/N)	N/A	N/A	DWS	Offset (in)
N/A	Shared Landing?	N/A			
N/A	Gutter Ponding?	N/A	N/A	Gutte	r Slope (%)
N/A	Gutter Lip Ht (in)	N/A	N/A	Gutte	er X Slope (%)
N/A	Painted X Walk1?	No	N/A	Paint	ed X Walk2?
	X Walk 1 Direction	To N		X Wa	lk 2 Direction
N/A	X Walk 1 Width (in)	N/A	N/A	X Wa	lk 2 Width (in)
	X Walk 1 Slope (%)	1.0		X Wa	lk 2 Slope (%)
	X Walk 1 X Slope (%)	0.4		X Wa	lk 2 X Slope (%)
N/A	Ramp inside XWalk1?	N/A	N/A	Ram	o inside XWalk2?

Possible Solution	
Possible Solutions:	Co
Remove & Replace Entire Ramp.	N/A
•	Yes
	N/A
	N/A
	N/A
	N/A
Surveyor Notes:	N/A
N/A	N/A
	N/A
	N/A
	N/A
PROW/ADA:	N/A
Not Found, R304.5.3	N/A
,	N/A
	N/A
	N/A
