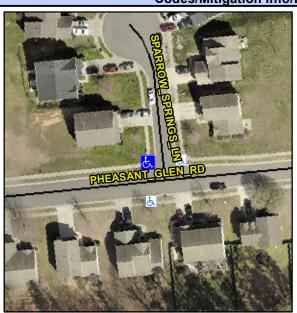
Total Cost: \$ 3200.00

Field Measurements/Component Compliance						
Compliance Description		Data	Comp	liance Description	Data	
N/A	Ramp Length (in)	44.0	Yes	Ramp Slope (%)	6.3	
No	Ramp Width (in)	45.5	No	Ramp XSlope (%)	10.1	
N/A	Flare Type LT	N/A	N/A	Flare Type RT	N/A	
N/A	Flare Slope LT (%)	N/A	N/A	Flare Slope RT (%)	N/A	
N/A	Flare Traversable LT?	N/A	N/A	Flare Traversable RT?	N/A	
N/A	Landing Length (in)	N/A	N/A	DWS Provided?	N/A	
N/A	Landing Width (in)	N/A	N/A	DWS Contrast?	N/A	
N/A	Landing Slope (%)	N/A	N/A	DWS Length (in)	N/A	
N/A	Landing X Slope (%)	N/A	N/A	DWS Full Width?	N/A	
N/A	Landing Curb? (Y/N)	N/A	N/A	DWS Offset (in)	N/A	
N/A	Shared Landing?	N/A				
N/A	Gutter Ponding?	N/A	N/A	Gutter Slope (%)	N/A	
N/A	Gutter Lip Ht (in)	N/A	N/A	Gutter X Slope (%)	N/A	
N/A	Painted X Walk1?	No	N/A	Painted X Walk2?	No	
	X Walk 1 Direction	To S		X Walk 2 Direction	To E	
N/A	X Walk 1 Width (in)	N/A	N/A	X Walk 2 Width (in)	N/A	
	X Walk 1 Slope (%)	4.9		X Walk 2 Slope (%)	5.3

SPARROW SPRINGS LN
None
PHEASANT GLEN RD
StopSign

ossible Solution				
Possible Solutions:	9			
Remove & Replace Curb Ramp With				
Two New Directional Ramps or	1			
Equivalent.	1			
	1			
	1			
	1			
Surveyor Notes:	1			
N/A	1			
	1			
	ı			
	1			
PROW/ADA:	1			
Not Found, R304.5.1, R304.5.3	1			
	1			
	1
