Access Compliance Report

Public Rights-of-Way

(Curb Ramps)

Intersection ID: 53704	Main Street: MILLSTREAM RIDGE DR	Cross Street: MILLSTREAM RIDGE DR	Location: E
ADA ID: B841F1A9DD6E	Ramp Type: Combination1	Initial Pass/Fail: Fail	Overall Compliance: No
Severity Score: 33.75			
Codes/Mitigation Info/Possible Solution		Field Measurements/Component Compliance

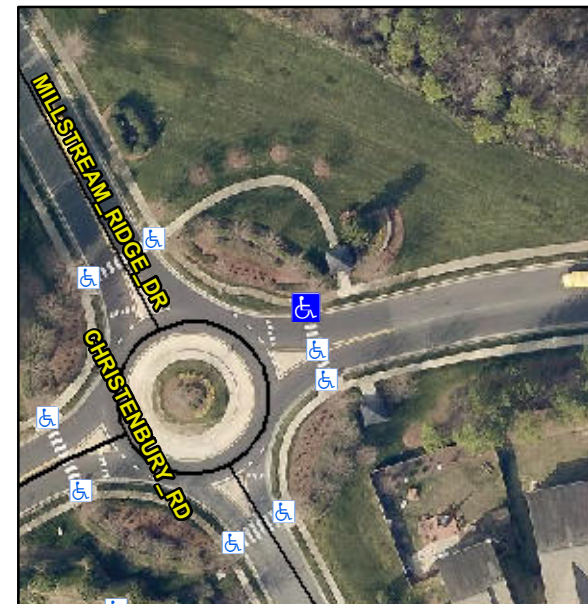
RT RP < 5%

R304.5.1, R304.5.3, R304.3.2

Compliance	Description	Data	Compliance	Description	Data
N/A	Ramp Length LT (in)	77.0	N/A	Ramp Length RT (in)	62.0
Yes	Ramp Width LT (in)	48.0	Yes	Ramp Width RT (in)	49.0
No	Ramp Slope LT (%)	10.6	Yes	Ramp Slope RT (%)	1.6
Yes	Ramp XSlope LT (%)	2.0	No	Ramp XSlope RT (%)	5.7
N/A	Ramp Length (in)	48.0	Yes	Ramp Slope (%)	5.6
No	Ramp Width (in)	47.0	No	Ramp XSlope (%)	3.6
N/A	Flare Type LT	N/A	N/A	Flare Type RT	N/A
N/A	Flare Slope LT (%)	N/A	N/A	Flare Slope RT (%)	N/A
N/A	Flare Traversable LT?	N/A	N/A	Flare Traversable RT?	N/A
N/A	Landing Length (in)	N/A	N/A	DWS Provided?	N/A
N/A	Landing Width (in)	N/A	N/A	DWS Contrast?	N/A
N/A	Landing Slope (%)	N/A	N/A	DWS Length (in)	N/A
N/A	Landing X Slope (%)	N/A	N/A	DWS Full Width?	N/A
N/A	Landing Curb? (Y/N)	N/A	N/A	DWS Offset (in)	N/A
N/A	Shared Landing?	N/A			
N/A	Gutter Ponding?	N/A	N/A	Gutter Slope (%)	N/A
N/A	Gutter Lip Ht (in)	N/A	N/A	Gutter X Slope (%)	N/A
N/A	Painted X Walk1?	Yes	N/A	Painted X Walk2?	N/A

X Walk 1 Direction	To SE		X Walk 2 Direction	N/A
	X Walk 1 Width (in)	72.0		X Walk 2 Width (in)	N/A
	X Walk 1 Slope (%)	3.1		X Walk 2 Slope (%)	N/A
	X Walk 1 X Slope (%)	3.5		X Walk 2 X Slope (%)	N/A
N/A	Ramp inside XWalk1?	Yes	N/A	Ramp inside XWalk2?	N/A
	Road Slope (%)	N/A		Clear Space?	N/A
	Road X Slope (%)	N/A	N/A	Clear Space to XWalk (in)	N/A
			N/A	Any Obstruction?	N/A
				Obstruction Type	N/A
			N/A	Storm Grate/Utility Hazard?	N/A
				Storm Grate/Utility Type	N/A
			Yes	Surface Condition? (G/P)	Good
				Curb Slope (%)	N/A

Possible Solutions:

Remove & Replace Entire Ramp.
