# Access Compliance Report

## Public Rights-of-Way

### (Curb Ramps)

Intersection ID: 53893	Main Street: PERTH_MOOR_RD	Cross Street: HAMILTON_BRIDGE_RD	Location: SW
ADA ID: B84AB4855D6D	Ramp Type: Perp	Initial Pass/Fail: Fail	Overall Compliance: No
Codes/Mitigation Info/Possible Solution		Field Measurements/Component Compliance

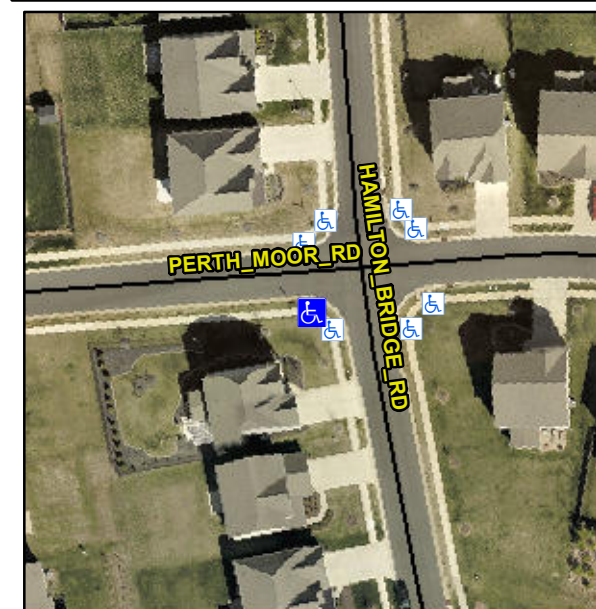
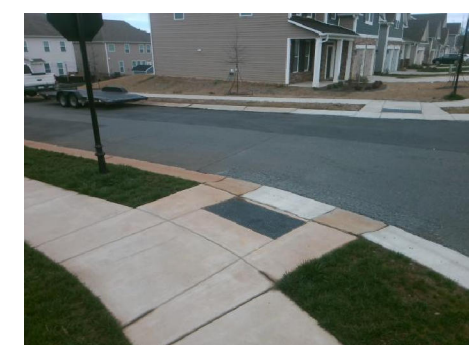
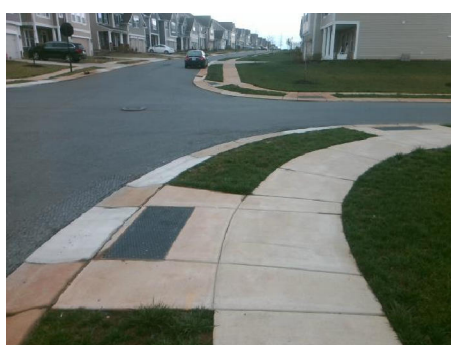
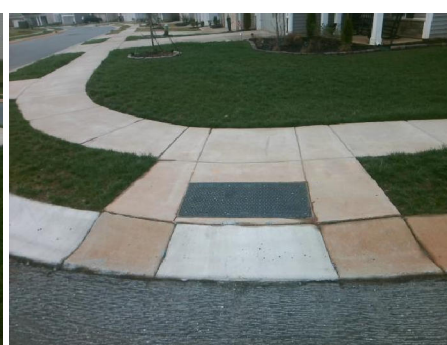
**Not Found, R304.5.1, R304.5.3**

Compliance	Description	Data	Compliance	Description	Data
N/A	Ramp Length (in)	47.0	Yes	Ramp Slope (%)	6.0
No	Ramp Width (in)	46.0	No	Ramp XSlope (%)	2.3
N/A	Flare Type LT	N/A	N/A	Flare Type RT	N/A
N/A	Flare Slope LT (%)	N/A	N/A	Flare Slope RT (%)	N/A
N/A	Flare Traversable LT?	N/A	N/A	Flare Traversable RT?	N/A
N/A	Landing Length (in)	N/A	N/A	DWS Provided?	N/A
N/A	Landing Width (in)	N/A	N/A	DWS Contrast?	N/A
N/A	Landing Slope (%)	N/A	N/A	DWS Length (in)	N/A
N/A	Landing X Slope (%)	N/A	N/A	DWS Full Width?	N/A
N/A	Landing Curb? (Y/N)	N/A	N/A	DWS Offset (in)	N/A
N/A	Shared Landing?	N/A			
N/A	Gutter Ponding?	N/A	N/A	Gutter Slope (%)	N/A
N/A	Gutter Lip Ht (in)	1.5	N/A	Gutter X Slope (%)	N/A
N/A	Painted X Walk1?	No	N/A	Painted X Walk2?	N/A
	X Walk 1 Direction	To N		X Walk 2 Direction	N/A
N/A	X Walk 1 Width (in)	N/A	N/A	X Walk 2 Width (in)	N/A
	X Walk 1 Slope (%)	0.0		X Walk 2 Slope (%)	N/A
	X Walk 1 X Slope (%)	0.7		X Walk 2 X Slope (%)	N/A

N/A	Ramp inside XWalk1?	N/A	N/A	Ramp inside XWalk2?	N/A
	Road Slope (%)	N/A	N/A	Clear Space?	N/A
	Road X Slope (%)	N/A	N/A	Clear Space to XWalk (in)	N/A
N/A	Any Obstructions?	N/A	N/A	Storm Grate/Utility Hazard?	N/A
	Obstruction Type			Storm Grate/Utility Type	
		N/A			N/A
			Yes	Surface Condition? (G/P)	Good

**Remove & Replace Entire Ramp.**

Total Cost: \$ 1850.00
