Access Compliance Report

Public Rights-of-Way

(Curb Ramps)

Intersection ID: 50242	Main Street: BLAIREBETH_ST	Cross Street: CEDAR_WALK_LN	Location: SW
ADA ID: B857A0C8A4D4	Ramp Type: PerpDiag	Initial Pass/Fail: Fail	Overall Compliance: No
Severity Score: 37.5			
Codes/Mitigation Info/Possible Solution		Field Measurements/Component Compliance

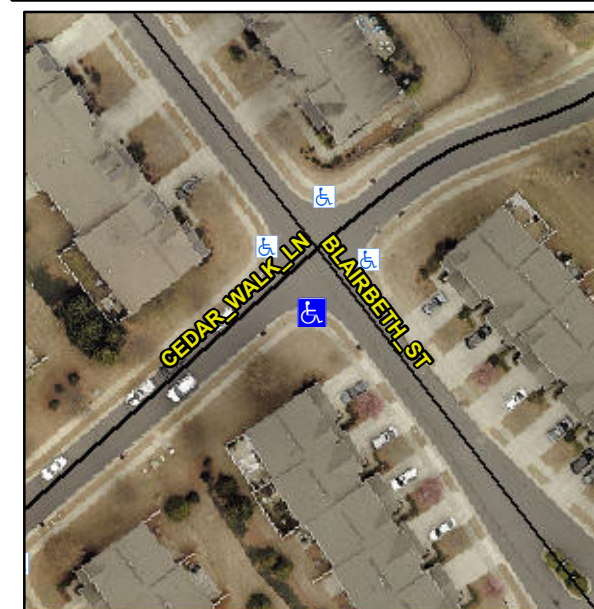
Not Found, R304.2.2, R304.5.3

Compliance	Description	Data	Compliance	Description	Data
N/A	Ramp Length (in)	46.0	No	Ramp Slope (%)	10.0
Yes	Ramp Width (in)	48.0	No	Ramp XSlope (%)	7.1
N/A	Flare Type LT	N/A	N/A	Flare Type RT	N/A
N/A	Flare Slope LT (%)	N/A	N/A	Flare Slope RT (%)	N/A
N/A	Flare Traversable LT?	N/A	N/A	Flare Traversable RT?	N/A
N/A	Landing Length (in)	N/A	N/A	DWS Provided?	N/A
N/A	Landing Width (in)	N/A	N/A	DWS Contrast?	N/A
N/A	Landing Slope (%)	N/A	N/A	DWS Length (in)	N/A
N/A	Landing X Slope (%)	N/A	N/A	DWS Full Width?	N/A
N/A	Landing Curb? (Y/N)	N/A	N/A	DWS Offset (in)	N/A
N/A	Shared Landing?	N/A			
N/A	Gutter Ponding?	N/A	N/A	Gutter Slope (%)	N/A
N/A	Gutter Lip Ht (in)	N/A	N/A	Gutter X Slope (%)	N/A
N/A	Painted X Walk1?	No	N/A	Painted X Walk2?	No
	X Walk 1 Direction	To NE		X Walk 2 Direction	To NW
N/A	X Walk 1 Width (in)	N/A	N/A	X Walk 2 Width (in)	N/A
	X Walk 1 Slope (%)	1.8		X Walk 2 Slope (%)	2.4
	X Walk 1 X Slope (%)	3.7		X Walk 2 X Slope (%)	5.2

N/A	Ramp inside XWalk1?	N/A	N/A	Ramp inside XWalk2?	N/A
	Road Slope (%)	7.4	N/A	Clear Space?	N/A
	Road X Slope (%)	2.1	N/A	Clear Space to XWalk (in)	N/A
N/A	Any Obstructions?	N/A	N/A	Storm Grate/Utility Hazard?	N/A
	Obstruction Type			Storm Grate/Utility Type	
		N/A			N/A
		Yes		Surface Condition? (G/P)	Good

Possible Solutions:

Remove & Replace Curb Ramp With Two New Directional Ramps or Equivalent.
