# Access Compliance Report

## Public Rights-of-Way

### (Curb Ramps)

Intersection ID: 10867	Main Street: E_35TH_ST	Cross Street: THE_PLAZA	Location:	N
ADA ID: B879B43E05E9	Ramp Type: PerpDiag	Initial Pass/Fail: Fail	Overall Compliance: No	Severity Score: 10

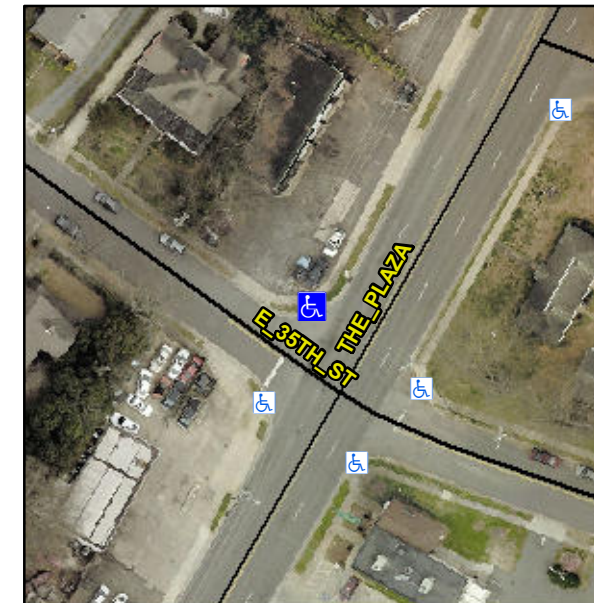
**Not Found, R304.5.1, R304.5.3**

Compliance	Description	Data	Compliance	Description	Data
N/A	Ramp Length (in)	48.0	Yes	Ramp Slope (%)	7.7
No	Ramp Width (in)	41.0	No	Ramp XSlope (%)	2.6
N/A	Flare Type LT	N/A	N/A	Flare Type RT	N/A
N/A	Flare Slope LT (%)	N/A	N/A	Flare Slope RT (%)	N/A
N/A	Flare Traversable LT?	N/A	N/A	Flare Traversable RT?	N/A
N/A	Landing Length (in)	N/A	N/A	DWS Provided?	N/A
N/A	Landing Width (in)	N/A	N/A	DWS Contrast?	N/A
N/A	Landing Slope (%)	N/A	N/A	DWS Length (in)	N/A
N/A	Landing X Slope (%)	N/A	N/A	DWS Full Width?	N/A
N/A	Landing Curb? (Y/N)	N/A	N/A	DWS Offset (in)	N/A
N/A	Shared Landing?	N/A			
N/A	Gutter Ponding?	N/A	N/A	Gutter Slope (%)	N/A
N/A	Gutter Lip Ht (in)	N/A	N/A	Gutter X Slope (%)	N/A
N/A	Painted X Walk1?	No	N/A	Painted X Walk2?	No
	X Walk 1 Direction	To SE		X Walk 2 Direction	To SE
N/A	X Walk 1 Width (in)	N/A	N/A	X Walk 2 Width (in)	N/A
	X Walk 1 Slope (%)	3.1		X Walk 2 Slope (%)	3.3
	X Walk 1 X Slope (%)	1.2		X Walk 2 X Slope (%)	0.8

N/A	Ramp inside XWalk1?	N/A	N/A	Ramp inside XWalk2?	N/A
	Road Slope (%)	0.2	N/A	Clear Space?	N/A
	Road X Slope (%)	1.2	N/A	Clear Space to XWalk (in)	N/A
N/A	Any Obstructions?	N/A	N/A	Storm Grate/Utility Hazard?	N/A
	Obstruction Type			Storm Grate/Utility Type	
		N/A			N/A
			Yes	Surface Condition? (G/P)	Good

**Remove & Replace Curb Ramp With Two New Directional Ramps or Equivalent.**
