# Access Compliance Report

## Public Rights-of-Way

### (Curb Ramps)

Intersection ID: N/A	Main Street: YORK_CENTER	Cross Street: N/A	Location: NW
ADA ID: B87A2EB64942	Ramp Type: PerpDiag	Initial Pass/Fail: Fail	Overall Compliance: No
		Severity Score: 30

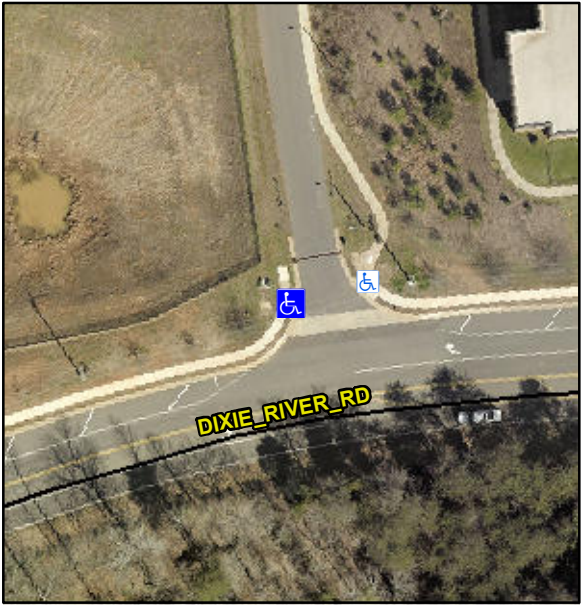
Possible Solutions:		<b>Compliance</b>	<b>Description</b>	<b>Data</b>
	<b>Remove &amp; Replace Curb Ramp With Two New Directional Ramps or Equivalent.</b>		N/A	Ramp Length (in)	94.0
			No	Ramp Width (in)	35.0
			N/A	Flare Type LT	N/A
			N/A	Flare Slope LT (%)	N/A
			N/A	Flare Traversable LT?	N/A
			N/A	Landing Length (in)	N/A
			N/A	Landing Width (in)	N/A
			N/A	Landing Slope (%)	N/A
			N/A	Landing X Slope (%)	N/A
			N/A	Landing Curb? (Y/N)	N/A
			N/A	Shared Landing?	N/A
			N/A	Gutter Ponding?	N/A
			N/A	Gutter Lip Ht (in)	N/A
			N/A	Painted X Walk1?	No
				X Walk 1 Direction	To S
			N/A	X Walk 1 Width (in)	N/A
				X Walk 1 Slope (%)	4.2
				X Walk 1 X Slope (%)	3.8
			N/A	Ramp inside XWalk1?	N/A
<p>Surveyor Notes:</p> <p><b>N/A</b></p> <p>PROW/ADA:</p> <p><b>Not Found, R304.5.1, R304.5.3</b></p>			N/A	Flare Type RT	N/A
			N/A	Flare Slope RT (%)	N/A

N/A	Flare Traversable RT?	N/A
			N/A	DWS Provided?	N/A
			N/A	DWS Contrast?	N/A
			N/A	DWS Length (in)	N/A
			N/A	DWS Full Width?	N/A
			N/A	DWS Offset (in)	N/A
			N/A	Gutter Slope (%)	N/A
			N/A	Gutter X Slope (%)	N/A
			N/A	Painted X Walk2?	No
				X Walk 2 Direction	To E
			N/A	X Walk 2 Width (in)	N/A
				X Walk 2 Slope (%)	4.0
				X Walk 2 X Slope (%)	4.8
			N/A	Ramp inside XWalk2?	N/A
			N/A	Clear Space?	N/A
			N/A	Clear Space to XWalk (in)	N/A
			N/A	Storm Grate/Utility Hazard?	N/A
				Storm Grate/Utility Type	
			N/A		N/A
			Yes	Surface Condition? (G/P)	Good
Total Cost:		\$ 3200.00
