Access Compliance Report

Public Rights-of-Way

(Curb Ramps)

Intersection ID: 28378	Main Street: BALDWIN_HALL_DR	Cross Street: SOUTHAMPTON_COMMONS_DR	Location:	N
ADA ID: B887CB1A3242	Ramp Type: Perp	Initial Pass/Fail: Fail	Overall Compliance: No	Severity Score: 25
Codes/Mitigation Info/Possible Solution		Field Measurements/Component Compliance

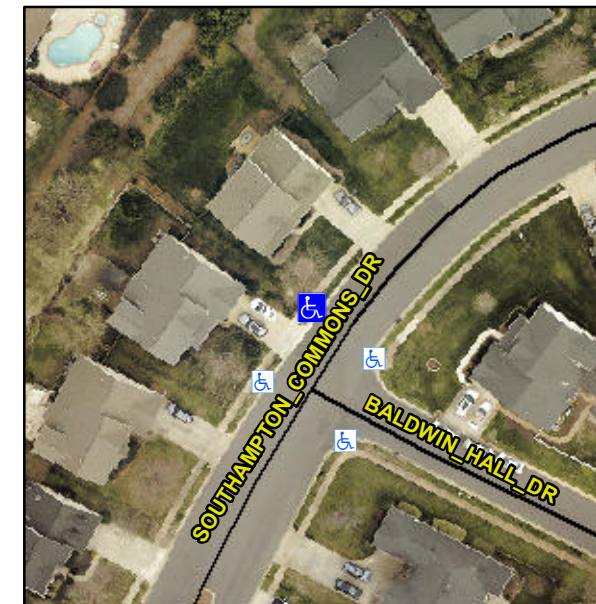
Not Found, R304.2.2, R304.5.3

Compliance	Description	Data	Compliance	Description	Data
N/A	Ramp Length (in)	49.0	No	Ramp Slope (%)	9.2
Yes	Ramp Width (in)	48.0	No	Ramp XSlope (%)	5.1
N/A	Flare Type LT	N/A	N/A	Flare Type RT	N/A
N/A	Flare Slope LT (%)	N/A	N/A	Flare Slope RT (%)	N/A
N/A	Flare Traversable LT?	N/A	N/A	Flare Traversable RT?	N/A
N/A	Landing Length (in)	N/A	N/A	DWS Provided?	N/A
N/A	Landing Width (in)	N/A	N/A	DWS Contrast?	N/A
N/A	Landing Slope (%)	N/A	N/A	DWS Length (in)	N/A
N/A	Landing X Slope (%)	N/A	N/A	DWS Full Width?	N/A
N/A	Landing Curb? (Y/N)	N/A	N/A	DWS Offset (in)	N/A
N/A	Shared Landing?	N/A			
N/A	Gutter Ponding?	N/A	N/A	Gutter Slope (%)	N/A
N/A	Gutter Lip Ht (in)	N/A	N/A	Gutter X Slope (%)	N/A
N/A	Painted X Walk1?	No	N/A	Painted X Walk2?	N/A
	X Walk 1 Direction	To SE		X Walk 2 Direction	N/A
N/A	X Walk 1 Width (in)	N/A	N/A	X Walk 2 Width (in)	N/A
	X Walk 1 Slope (%)	0.6		X Walk 2 Slope (%)	N/A
	X Walk 1 X Slope (%)	4.5		X Walk 2 X Slope (%)	N/A

N/A	Ramp inside XWalk1?	N/A	N/A	Ramp inside XWalk2?	N/A
	Road Slope (%)	N/A	N/A	Clear Space?	N/A
	Road X Slope (%)	N/A	N/A	Clear Space to XWalk (in)	N/A
N/A	Any Obstructions?	N/A	N/A	Storm Grate/Utility Hazard?	N/A
	Obstruction Type			Storm Grate/Utility Type	
		N/A			N/A
			Yes	Surface Condition? (G/P)	Good

Possible Solutions:

Remove & Replace Entire Ramp.
