Access Compliance Report

Public Rights-of-Way

(Curb Ramps)

Intersection ID: N/A	Main Street: ENDAHVEN_VILLAGE_DR	Cross Street: ENDAHVEN_LN	Location: NE
ADA ID: B89467CE95F1	Ramp Type: Directional1	Initial Pass/Fail: Fail	Overall Compliance: No
Codes/Mitigation Info/Possible Solution		Field Measurements/Component Compliance

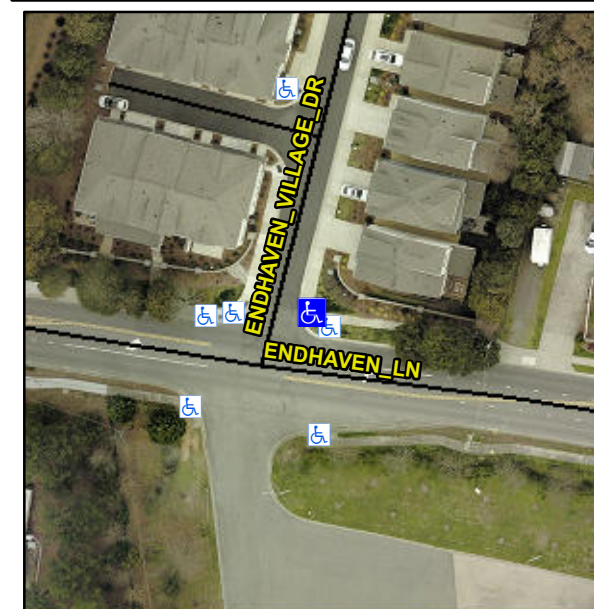
Compliance	Description	Data	Compliance	Description	Data
N/A	Ramp Length (in)	73.0	N/A	Grade Break?	N/A
Yes	Ramp Width (in)	60.0	N/A	Grade Break Slope (%)	0.0
Yes	Ramp Slope (%)	7.4	N/A	Grade Break XSlope (%)	0.0
No	Ramp XSlope (%)	3.8			
N/A	Flare Type LT	N/A	N/A	Flare Type RT	N/A
N/A	Flare Slope LT (%)	N/A	N/A	Flare Slope RT (%)	0.0
N/A	Flare Traversable LT?	N/A	N/A	Flare Traversable RT?	N/A
N/A	Landing Length (in)	0.0	N/A	DWS Provided?	N/A
N/A	Landing Width (in)	0.0	N/A	DWS Contrast?	N/A
N/A	Landing Slope (%)	0.0	N/A	DWS Length (in)	N/A
N/A	Landing X Slope (%)	0.0	N/A	DWS Full Width?	N/A
N/A	Landing Curb? (Y/N)	N/A	N/A	DWS Offset LT (in)	N/A
N/A	Shared Landing?	N/A	N/A	DWS Offset RT (in)	N/A
N/A	Gutter Ponding?	0.0	N/A	Gutter Slope (%)	N/A
N/A	Gutter Lip Ht (in)	0.0	N/A	Gutter X Slope (%)	N/A
N/A	Painted X Walk1?	No		Road Slope (%)	3.4
	X Walk 1 Direction	To SW		Road X Slope (%)	1.3
	X Walk 1 Width (in)	N/A		Clear Space?	N/A

X Walk 1 Slope (%)	3.4	N/A	Clear Space to XWalk (in)	N/A
	X Walk 1 X Slope (%)	1.3	N/A	Storm Grate/Utility Hazard?	N/A
N/A	Ramp inside XWalk1?	N/A		Storm Grate/Utility Type	
N/A	Any Obstructions?	N/A			N/A
	Obstruction Type		Yes	Surface Condition? (G/P)	Good
			N/A	Curb Slope (%)	2.7

Possible Solutions:

Remove & Replace Entire Ramp.

PROW/ADA:

R304.5.3
