## Access Compliance Report Public Rights-of-Way (Curb Ramps)

Intersection ID: N/AMain Street: SHARON\_ACRES\_RDCross Street: SHARON\_RIDGE\_LNLocation:NEADA ID: B89BCEE5D98CRamp Type: ParaDiagInitial Pass/Fail: FailOverall Compliance: NoSeverity Score:22.5

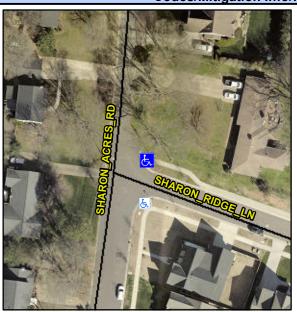
Compliance Description		Data	Compliance Description		Data
N/A	Ramp Length LT (in)	38.0	N/A	Ramp Length RT (in)	36.0
No	Ramp Width LT (in)	38.0	Yes	Ramp Width RT (in)	60.0
No	Ramp Slope LT (%)	11.1	Yes	Ramp Slope RT (%)	7.6
No	Ramp XSlope LT (%)	2.6	Yes	Ramp XSlope RT (%)	0.1
N/A	Landing Length (in)	N/A	N/A	DWS Provided?	N/A
N/A	Landing Width (in)	N/A	N/A	DWS Contrast?	N/A
N/A	Landing Slope (%)	N/A	N/A	DWS Length (in)	N/A
N/A	Landing X Slope (%)	N/A	N/A	DWS Full Width?	N/A
N/A	Landing Curb? (Y/N)	N/A	N/A	DWS Offset (in)	N/A
N/A	Shared Landing?	N/A			
N/A	Gutter Ponding?	N/A	N/A	Gutter Slope (%)	N/A
N/A	Gutter Lip Ht (in)	N/A	N/A	Gutter X Slope (%)	N/A
N/A	Painted X Walk1?	No	N/A	Painted X Walk2?	No
	X Walk 1 Direction	To W		X Walk 2 Direction	To S
N/A	X Walk 1 Width (in)	N/A	N/A	X Walk 2 Width (in)	N/A
	X Walk 1 Slope (%)	3.4		X Walk 2 Slope (%)	3.2
	X Walk 1 X Slope (%)	4.7		X Walk 2 X Slope (%)	5.4
N/A	Ramp inside XWalk1?	N/A	N/A	Ramp inside XWalk2?	N/A

Road Slope (%)	7.3	N/A	Clear Space?	N/A
	Road X Slope (%)	2.6	N/A	Clear Space to XWalk (in)	N/A
N/A	Any Obstructions?	N/A	N/A	Storm Grate/Utility Hazard?	N/A
	Obstruction Type			Storm Grate/Utility Type	
		N/A			N/A
			Yes	Surface Condition? (G/P)	Good
			N/A	Curb Slope (%)	13.8
( )

SHARON ACRES RD None SHARON RIDGE LN StopSign Possible Solutions:

Remove & Replace Curb Ramp With Two New Directional Ramps or Equivalent.
