# Access Compliance Report

## Public Rights-of-Way

### (Curb Ramps)

Intersection ID: N/A	Main Street: COSTIGAN_LN	Cross Street: N/A	Location: E
ADA ID: B8A5689C74C9	Ramp Type: PerpDiag	Initial Pass/Fail: Fail	Overall Compliance: No
Severity Score: 22.5			
Codes/Mitigation Info/Possible Solution		Field Measurements/Component Compliance

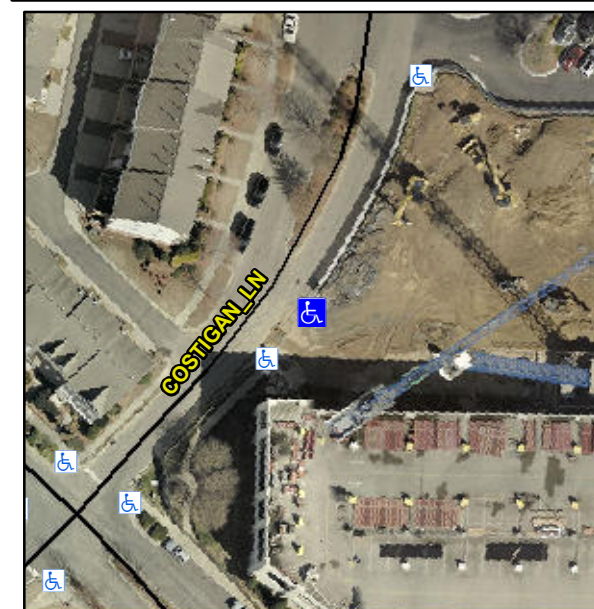
**Not Found, R304.5.1, R304.2.2, R304.5.3**

Compliance	Description	Data	Compliance	Description	Data
N/A	Ramp Length (in)	84.0	No	Ramp Slope (%)	9.1
No	Ramp Width (in)	46.0	No	Ramp XSlope (%)	3.2
N/A	Flare Type LT	N/A	N/A	Flare Type RT	N/A
N/A	Flare Slope LT (%)	N/A	N/A	Flare Slope RT (%)	N/A
N/A	Flare Traversable LT?	N/A	N/A	Flare Traversable RT?	N/A
N/A	Landing Length (in)	N/A	N/A	DWS Provided?	N/A
N/A	Landing Width (in)	N/A	N/A	DWS Contrast?	N/A
N/A	Landing Slope (%)	N/A	N/A	DWS Length (in)	N/A
N/A	Landing X Slope (%)	N/A	N/A	DWS Full Width?	N/A
N/A	Landing Curb? (Y/N)	N/A	N/A	DWS Offset (in)	N/A
N/A	Shared Landing?	N/A			
N/A	Gutter Ponding?	N/A	N/A	Gutter Slope (%)	N/A
N/A	Gutter Lip Ht (in)	N/A	N/A	Gutter X Slope (%)	N/A
N/A	Painted X Walk1?	No	N/A	Painted X Walk2?	No
	X Walk 1 Direction	To NW		X Walk 2 Direction	To SW
N/A	X Walk 1 Width (in)	N/A	N/A	X Walk 2 Width (in)	N/A
	X Walk 1 Slope (%)	5.1		X Walk 2 Slope (%)	1.0
	X Walk 1 X Slope (%)	0.7		X Walk 2 X Slope (%)	4.4

N/A	Ramp inside XWalk1?	N/A	N/A	Ramp inside XWalk2?	N/A
	Road Slope (%)	4.0	N/A	Clear Space?	N/A
	Road X Slope (%)	2.7	N/A	Clear Space to XWalk (in)	N/A
N/A	Any Obstructions?	N/A	N/A	Storm Grate/Utility Hazard?	N/A
	Obstruction Type			Storm Grate/Utility Type	
		N/A			N/A
			Yes	Surface Condition? (G/P)	Good

**Remove & Replace Curb Ramp With Two New Directional Ramps or Equivalent.**
