Access Compliance Report Public Rights-of-Way (Curb Ramps)

Intersection ID: 9925 Main Street: TENNYSON_DR **Cross Street: TUCKASEEGEE_RD** Location: N

ADA ID: B8A6F0160DC2 Ramp Type: Perp Initial Pass/Fail: Fail **Overall Compliance: No** Severity Score: 13.75

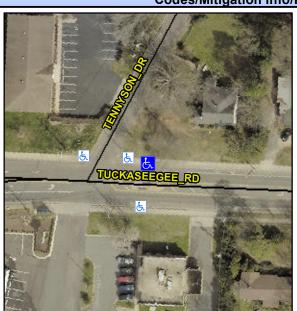
Field Measurements/Component Compliance								
Compl	iance Description	Data	Compl	iance Description	Data			
N/A	Ramp Length (in)	70.0	No	Ramp Slope (%)	8.6			
Yes	Ramp Width (in)	48.0	No	Ramp XSlope (%)	2.3			
N/A	Flare Type LT	N/A	N/A	Flare Type RT	N/A			
N/A	Flare Slope LT (%)	N/A	N/A	Flare Slope RT (%)	N/A			
N/A	Flare Traversable LT?	N/A	N/A	Flare Traversable RT?	N/A			
N/A	Landing Length (in)	N/A	N/A	DWS Provided?	N/A			
N/A	Landing Width (in)	N/A	N/A	DWS Contrast?	N/A			
N/A	Landing Slope (%)	N/A	N/A	DWS Length (in)	N/A			
N/A	Landing X Slope (%)	N/A	N/A	DWS Full Width?	N/A			
N/A	Landing Curb? (Y/N)	N/A	N/A	DWS Offset (in)	N/A			
N/A	Shared Landing?	N/A						
N/A	Gutter Ponding?	N/A	N/A	Gutter Slope (%)	N/A			
N/A	Gutter Lip Ht (in)	N/A	N/A	Gutter X Slope (%)	N/A			
N/A	Painted X Walk1?	No	N/A	Painted X Walk2?	N/A			
	X Walk 1 Direction	To S		X Walk 2 Direction	N/A			
N/A	X Walk 1 Width (in)	N/A	N/A	X Walk 2 Width (in)	N/A

X Walk 1 Slope (%)	5.8		X Walk 2 Slope (%)	N/A			
	X Walk 1 X Slope (%)	2.2		X Walk 2 X Slope (%)	N/A			
N/A	Ramp inside XWalk1?	N/A	N/A	Ramp inside XWalk2?	N/A			
	Road Slope (%)	N/A	N/A	Clear Space?	N/A			
	Road X Slope (%)	N/A	N/A	Clear Space to XWalk (in)	N/A			
N/A	Any Obstructions?	N/A	N/A	Storm Grate/Utility Hazard?	N/A			
	Obstruction Type			Storm Grate/Utility Type				
		N/A			N/A			
			Yes	Surface Condition? (G/P)	Good

Possible Solutions:	9
Remove & Replace Entire Ramp.	ı
	١
	N
	ı
	ı
	ı
Surveyor Notes:	ı
N/A	ı
	1
	ı
	ı
PROW/ADA:	ı
Not Found, R304.2.2, R304.5.3	N
	ı
	ı
	1
