## Access Compliance Report Public Rights-of-Way (Curb Ramps)

Intersection ID: 15882 Main Street: EAST\_BV Cross Street: QUEENS\_RD\_WEST Location: NW

ADA ID: B8B472817ECB Ramp Type: PerpDiag Initial Pass/Fail: Fail Overall Compliance: No Severity Score: 12.5

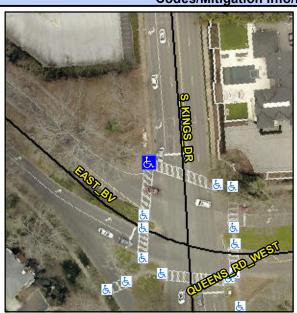
Field Measurements/Component Compliance						
	Compliance Description		Data	Comp	oliance Description	Data
	N/A	Ramp Length (in)	55.0	Yes	Ramp Slope (%)	6.5
	Yes	Ramp Width (in)	48.0	No	Ramp XSlope (%)	6.3
	N/A	Flare Type LT	N/A	N/A	Flare Type RT	N/A
	N/A	Flare Slope LT (%)	N/A	N/A	Flare Slope RT (%)	N/A
	N/A	Flare Traversable LT?	N/A	N/A	Flare Traversable RT?	N/A
	N/A	Landing Length (in)	N/A	N/A	DWS Provided?	N/A
	N/A	Landing Width (in)	N/A	N/A	DWS Contrast?	N/A
	N/A	Landing Slope (%)	N/A	N/A	DWS Length (in)	N/A
	N/A	Landing X Slope (%)	N/A	N/A	DWS Full Width?	N/A
	N/A	Landing Curb? (Y/N)	N/A	N/A	DWS Offset (in)	N/A
	N/A	Shared Landing?	N/A			
	N/A	Gutter Ponding?	N/A	N/A	Gutter Slope (%)	N/A
	N/A	Gutter Lip Ht (in)	N/A	N/A	Gutter X Slope (%)	N/A
	N/A	Painted X Walk1?	Yes	N/A	Painted X Walk2?	Yes
		X Walk 1 Direction	To SW		X Walk 2 Direction	To SE
	N/A	X Walk 1 Width (in)	109.0	N/A	X Walk 2 Width (in)	110.0

X Walk 1 Slope (%)	1.4		X Walk 2 Slope (%)	5.8
		X Walk 1 X Slope (%)	3.2		X Walk 2 X Slope (%)	1.1
	N/A	Ramp inside XWalk1?	Yes	N/A	Ramp inside XWalk2?	Yes
		Road Slope (%)	1.6	N/A	Clear Space?	N/A
		Road X Slope (%)	5.3	N/A	Clear Space to XWalk (in)	N/A
	N/A	Any Obstructions?	N/A	N/A	Storm Grate/Utility Hazard?	N/A
		Obstruction Type			Storm Grate/Utility Type	
			N/A			N/A
				Yes	Surface Condition? (G/P)	Good
.00

Remove & Replace Curb Ramp With Two New Directional Ramps or Equivalent.
