Access Compliance Report

Public Rights-of-Way

(Curb Ramps)

Intersection ID: 3032	Main Street: FOX_GLEN_RD	Cross Street: FOX_HILL_DR	Location: S
ADA ID: B8BC789FDE6E	Ramp Type: Perp	Initial Pass/Fail: Fail	Overall Compliance: No
Severity Score: 1.25			
Codes/Mitigation Info/Possible Solution		Field Measurements/Component Compliance

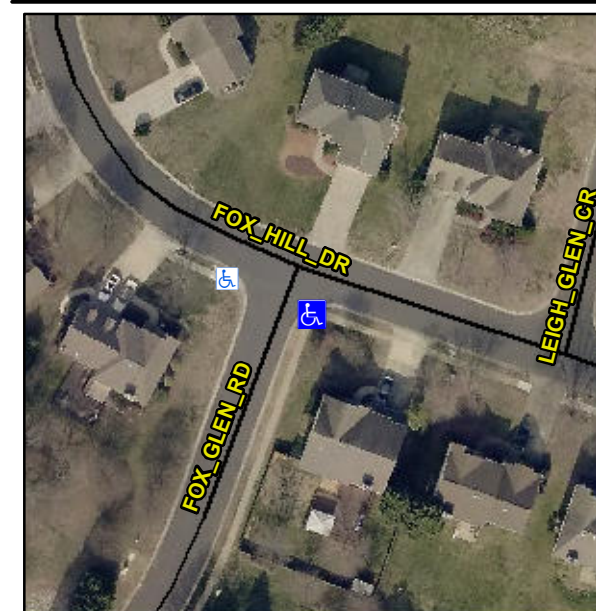
Not Found, R304.5.3

Compliance	Description	Data	Compliance	Description	Data
N/A	Ramp Length (in)	62.0	Yes	Ramp Slope (%)	6.9
Yes	Ramp Width (in)	48.0	No	Ramp XSlope (%)	3.6
N/A	Flare Type LT	N/A	N/A	Flare Type RT	N/A
N/A	Flare Slope LT (%)	N/A	N/A	Flare Slope RT (%)	N/A
N/A	Flare Traversable LT?	N/A	N/A	Flare Traversable RT?	N/A
N/A	Landing Length (in)	N/A	N/A	DWS Provided?	N/A
N/A	Landing Width (in)	N/A	N/A	DWS Contrast?	N/A
N/A	Landing Slope (%)	N/A	N/A	DWS Length (in)	N/A
N/A	Landing X Slope (%)	N/A	N/A	DWS Full Width?	N/A
N/A	Landing Curb? (Y/N)	N/A	N/A	DWS Offset (in)	N/A
N/A	Shared Landing?	N/A			
N/A	Gutter Ponding?	N/A	N/A	Gutter Slope (%)	N/A
N/A	Gutter Lip Ht (in)	N/A	N/A	Gutter X Slope (%)	N/A
N/A	Painted X Walk1?	No	N/A	Painted X Walk2?	N/A
	X Walk 1 Direction	To NW		X Walk 2 Direction	N/A
N/A	X Walk 1 Width (in)	N/A	N/A	X Walk 2 Width (in)	N/A
	X Walk 1 Slope (%)	5.4		X Walk 2 Slope (%)	N/A
	X Walk 1 X Slope (%)	2.4		X Walk 2 X Slope (%)	N/A

N/A	Ramp inside XWalk1?	N/A	N/A	Ramp inside XWalk2?	N/A
	Road Slope (%)	N/A	N/A	Clear Space?	N/A
	Road X Slope (%)	N/A	N/A	Clear Space to XWalk (in)	N/A
N/A	Any Obstructions?	N/A	N/A	Storm Grate/Utility Hazard?	N/A
	Obstruction Type			Storm Grate/Utility Type	
		N/A			N/A
		Yes		Surface Condition? (G/P)	Good

Possible Solutions:

Remove & Replace Entire Ramp.

Total Cost: \$ 1850.00
