# Access Compliance Report

## Public Rights-of-Way

### (Curb Ramps)

| Intersection ID: 2683 | Main Street: FAIRVISTA_DR | Cross Street: REGAL_CT | Location: NE |

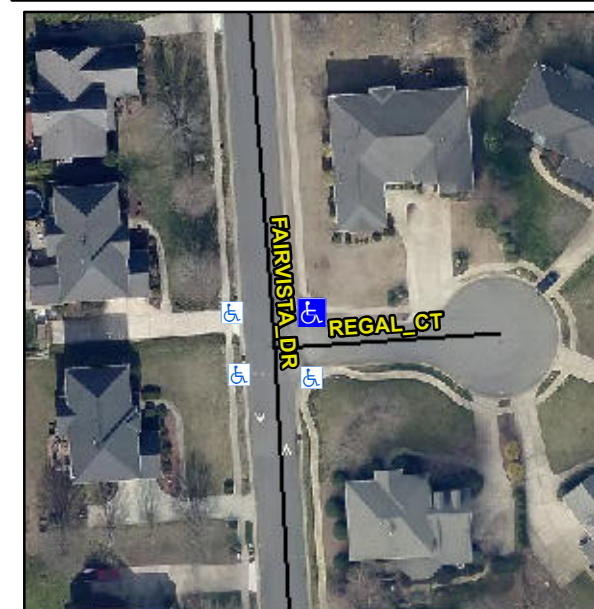
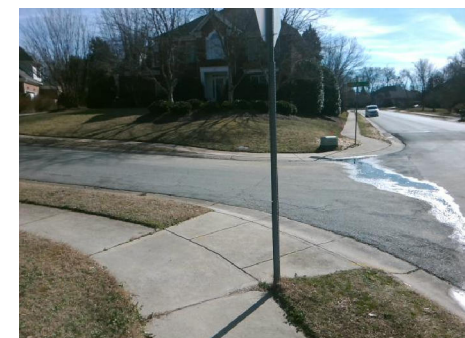
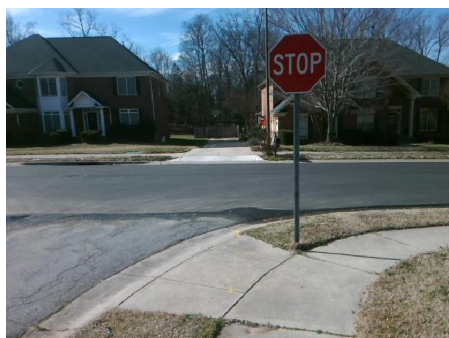
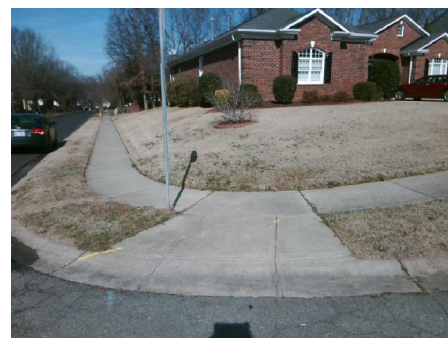
| ADA ID: B8BD58B793F0 | Ramp Type: BlendTrans1 | Initial Pass/Fail: Fail | Overall Compliance: No |
| | | | Severity Score: 21.25 |

**Not Found, R304.5.1, R304.5.3**

| Compliance | Description | Data | Compliance | Description | Data |
|---|---|---|---|---|---|
| No | Ramp Width (in) | 44.0 | No | BlendTrans XSlope (%) | 5.1 |
| | | | No | Curb Slope (%) | 12.1 |

**Remove & Replace Curb Ramp With Two New Directional Ramps or Equivalent.**

Total Cost: \$ 3200.00
