Access Compliance Report

Public Rights-of-Way

(Curb Ramps)

Intersection ID: N/A	Main Street: MINTVALE_DR	Cross Street: PALUSTRIS_CT	Location: S
ADA ID: B8C0B6E4F03F	Ramp Type: Perp	Initial Pass/Fail: Fail	Overall Compliance: No
Severity Score: 13.75			
Codes/Mitigation Info/Possible Solution		Field Measurements/Component Compliance

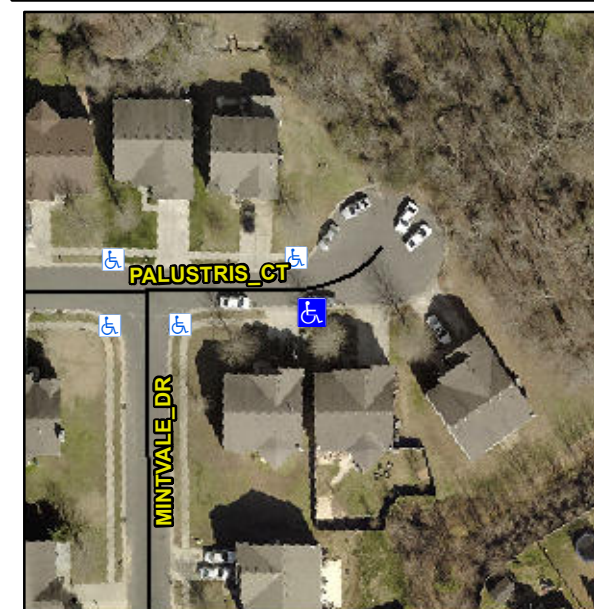
Not Found, R304.2.2, R304.5.3

Compliance	Description	Data	Compliance	Description	Data
N/A	Ramp Length (in)	46.5	No	Ramp Slope (%)	8.8
Yes	Ramp Width (in)	81.0	No	Ramp XSlope (%)	2.1
N/A	Flare Type LT	N/A	N/A	Flare Type RT	N/A
N/A	Flare Slope LT (%)	N/A	N/A	Flare Slope RT (%)	N/A
N/A	Flare Traversable LT?	N/A	N/A	Flare Traversable RT?	N/A
N/A	Landing Length (in)	N/A	N/A	DWS Provided?	N/A
N/A	Landing Width (in)	N/A	N/A	DWS Contrast?	N/A
N/A	Landing Slope (%)	N/A	N/A	DWS Length (in)	N/A
N/A	Landing X Slope (%)	N/A	N/A	DWS Full Width?	N/A
N/A	Landing Curb? (Y/N)	N/A	N/A	DWS Offset (in)	N/A
N/A	Shared Landing?	N/A			
N/A	Gutter Ponding?	N/A	N/A	Gutter Slope (%)	N/A
N/A	Gutter Lip Ht (in)	N/A	N/A	Gutter X Slope (%)	N/A
N/A	Painted X Walk1?	No	N/A	Painted X Walk2?	N/A
	X Walk 1 Direction	To N		X Walk 2 Direction	N/A
N/A	X Walk 1 Width (in)	N/A	N/A	X Walk 2 Width (in)	N/A
	X Walk 1 Slope (%)	3.9		X Walk 2 Slope (%)	N/A
	X Walk 1 X Slope (%)	0.1		X Walk 2 X Slope (%)	N/A

N/A	Ramp inside XWalk1?	N/A	N/A	Ramp inside XWalk2?	N/A
	Road Slope (%)	N/A	N/A	Clear Space?	N/A
	Road X Slope (%)	N/A	N/A	Clear Space to XWalk (in)	N/A
N/A	Any Obstructions?	N/A	N/A	Storm Grate/Utility Hazard?	N/A
	Obstruction Type			Storm Grate/Utility Type	
		N/A			N/A
			Yes	Surface Condition? (G/P)	Good

Possible Solutions:

Remove & Replace Entire Ramp.
