# Access Compliance Report

## Public Rights-of-Way

### (Curb Ramps)

| Intersection ID: 22069 | Main Street: CARMEL_RD | Cross Street: KNAPDALE_LN | Location: N |

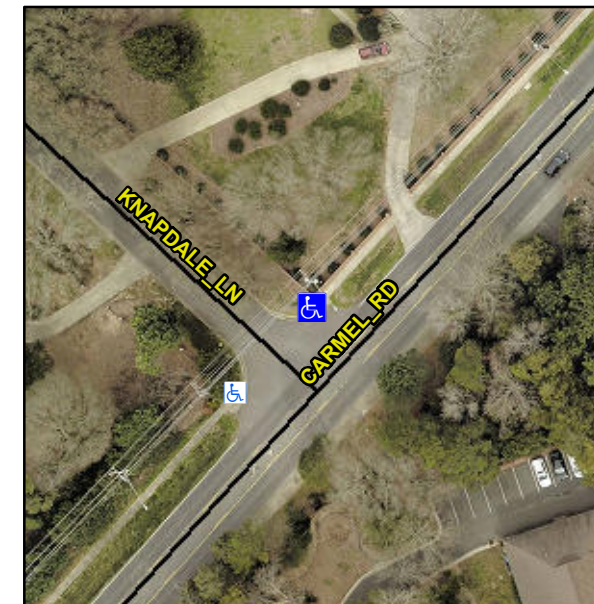
**ASP LIP 1.0", CURB LIP 1.5"**

**R304.2.2, R304.5.3**

| Compliance | Description | Data | Compliance | Description | Data |
|---|---|---|---|---|---|
| No | Ramp Slope (%) | 11.8 | N/A | Grade Break XSlope (%) | 0.0 |
| No | Ramp XSlope (%) | 2.3 | | | |

**Remove & Replace Entire Ramp.**
