## **Access Compliance Report Public Rights-of-Way** (Curb Ramps)

Intersection ID: 10024336 Main Street: CREEKRIDGE\_RD Cross Street: N/A Location: SE **Overall Compliance: No** ADA ID: B8CAD90219AE Ramp Type: Perp Initial Pass/Fail: Fail **Severity Score:** 25

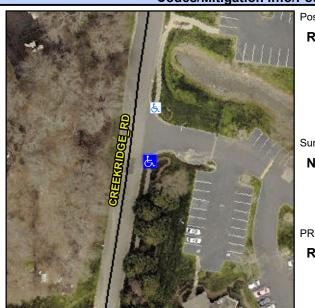
Comp	oliance Description	Data	Comp	liance Description	Data
N/A	Ramp Length (in)	64.0	No	Ramp Slope (%)	14.9
Yes	Ramp Width (in)	48.0	Yes	Ramp XSlope (%)	1.1
N/A	Flare Type LT	N/A	N/A	Flare Type RT	N/A
N/A	Flare Slope LT (%)	N/A	N/A	Flare Slope RT (%)	N/A
N/A	Flare Traversable LT?	N/A	N/A	Flare Traversable RT?	N/A
N/A	Landing Length (in)	N/A	N/A	DWS Provided?	N/A
N/A	Landing Width (in)	N/A	N/A	DWS Contrast?	N/A
N/A	Landing Slope (%)	N/A	N/A	DWS Length (in)	N/A
N/A	Landing X Slope (%)	N/A	N/A	DWS Full Width?	N/A
N/A	Landing Curb? (Y/N)	N/A	N/A	DWS Offset (in)	N/A
N/A	Shared Landing?	N/A			
N/A	Gutter Ponding?	N/A	N/A	Gutter Slope (%)	N/A
N/A	Gutter Lip Ht (in)	N/A	N/A	Gutter X Slope (%)	N/A
N/A	Painted X Walk1?	No	N/A	Painted X Walk2?	N/A
	X Walk 1 Direction	To NE		X Walk 2 Direction	N/A
N/A	X Walk 1 Width (in)	N/A	N/A	X Walk 2 Width (in)	N/A
	X Walk 1 Slope (%)	5.9		X Walk 2 Slope (%)	N/A
	X Walk 1 X Slope (%)	14.5		X Walk 2 X Slope (%)	N/A

N/A	Ramp inside XWalk1?	N/A	N/A	Ramp inside XWalk2?	N/A
	Road Slope (%)	N/A	N/A	Clear Space?	N/A
	Road X Slope (%)	N/A	N/A	Clear Space to XWalk (in)	N/A
N/A	Any Obstructions?	N/A	N/A	Storm Grate/Utility Hazard?	N/A
	Obstruction Type			Storm Grate/Utility Type	
		N/A			N/A
			Yes	Surface Condition? (G/P)	Good

ossible Solutions:	<u>c</u>
Remove & Replace Entire Ramp.	
•	Υ
	N
	N
	N
	N
ırveyor Notes:	N
N/A	N
	N
	N
	N
ROW/ADA:	N
R304.2.2	N
	N
	N
	N
