# Access Compliance Report

## Public Rights-of-Way

### (Curb Ramps)

Intersection ID: 14923	Main Street: EAST_BV	Cross Street: EWING_AV	Location: SW
ADA ID: B8D88B21E898	Ramp Type: Perp	Initial Pass/Fail: Fail	Overall Compliance: No
		Severity Score: 37.5

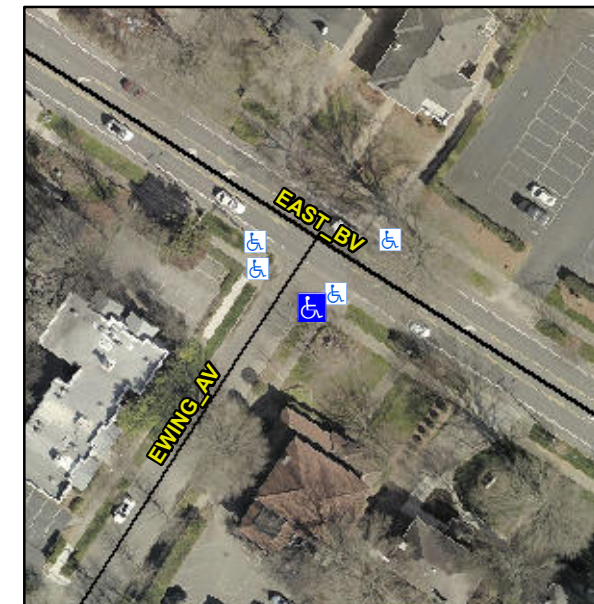
**Not Found, R304.2.2, R304.5.3**

Compliance	Description	Data	Compliance	Description	Data
N/A	Ramp Length (in)	102.0	No	Ramp Slope (%)	9.6
Yes	Ramp Width (in)	71.0	No	Ramp XSlope (%)	7.2
N/A	Flare Type LT	N/A	N/A	Flare Type RT	N/A
N/A	Flare Slope LT (%)	N/A	N/A	Flare Slope RT (%)	N/A
N/A	Flare Traversable LT?	N/A	N/A	Flare Traversable RT?	N/A
N/A	Landing Length (in)	N/A	N/A	DWS Provided?	N/A
N/A	Landing Width (in)	N/A	N/A	DWS Contrast?	N/A
N/A	Landing Slope (%)	N/A	N/A	DWS Length (in)	N/A
N/A	Landing X Slope (%)	N/A	N/A	DWS Full Width?	N/A
N/A	Landing Curb? (Y/N)	N/A	N/A	DWS Offset (in)	N/A
N/A	Shared Landing?	N/A			
N/A	Gutter Ponding?	N/A	N/A	Gutter Slope (%)	N/A
N/A	Gutter Lip Ht (in)	N/A	N/A	Gutter X Slope (%)	N/A
N/A	Painted X Walk1?	No	N/A	Painted X Walk2?	N/A
	X Walk 1 Direction	To NW		X Walk 2 Direction	N/A
N/A	X Walk 1 Width (in)	N/A	N/A	X Walk 2 Width (in)	N/A
	X Walk 1 Slope (%)	5.5		X Walk 2 Slope (%)	N/A
	X Walk 1 X Slope (%)	3.4		X Walk 2 X Slope (%)	N/A

N/A	Ramp inside XWalk1?	N/A	N/A	Ramp inside XWalk2?	N/A
	Road Slope (%)	N/A	N/A	Clear Space?	N/A
	Road X Slope (%)	N/A	N/A	Clear Space to XWalk (in)	N/A
N/A	Any Obstructions?	N/A	N/A	Storm Grate/Utility Hazard?	N/A
	Obstruction Type			Storm Grate/Utility Type	
		N/A			N/A
			Yes	Surface Condition? (G/P)	Good

**Remove & Replace Entire Ramp.**
