Access Compliance Report Public Rights-of-Way (Curb Ramps)

Intersection ID: 14980 Main Street: DILWORTH RD EAST **Cross Street: EAST BV** Location: ADA ID: B8E00538CC17 Ramp Type: Perp Initial Pass/Fail: Pass **Overall Compliance: No Severity Score:** 10

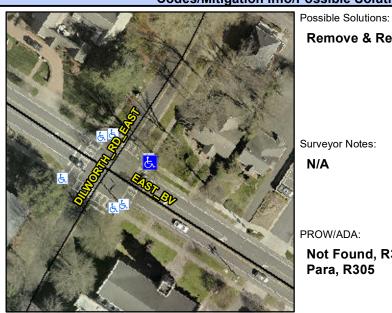
| Field Measurements/Component Compliance | | | | | |
|---|---|---|---|---|---|
| Yes | Landing Length (in) | 76.0 | No | DWS Provided? | No |
| No | Landing Slope (%) | 4.0 | N/A | DWS Length (in) | N/A |

Remove & Replace Entire Ramp. Surveyor Notes: N/A PROW/ADA: Not Found, R304.2.2-Perp, R304.3.2-Para, R305

Total Cost: 1850.00
