Access Compliance Report

Public Rights-of-Way

(Curb Ramps)

Intersection ID: 31894	Main Street: GREEN_MOUNTAIN_RD	Cross Street: MOUNTAIN_SPRINGS_DR	Location: SW
ADA ID: B8E22C36DA21	Ramp Type: PerpDiag	Initial Pass/Fail: Fail	Overall Compliance: No
Codes/Mitigation Info/Possible Solution		Field Measurements/Component Compliance	
Severity Score: 21.25

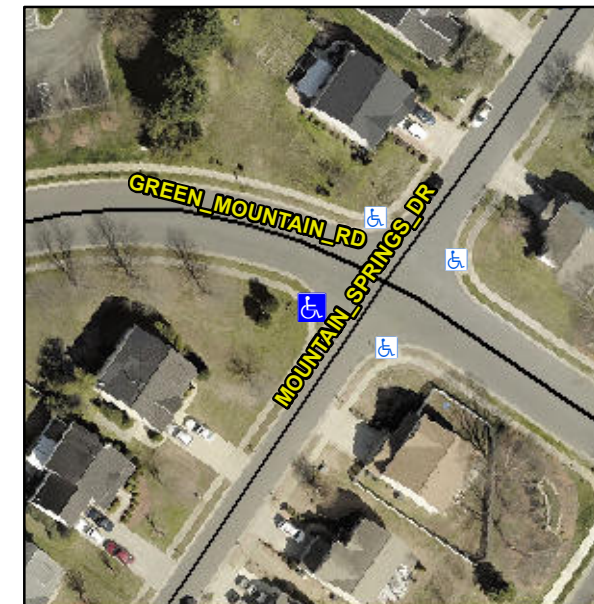
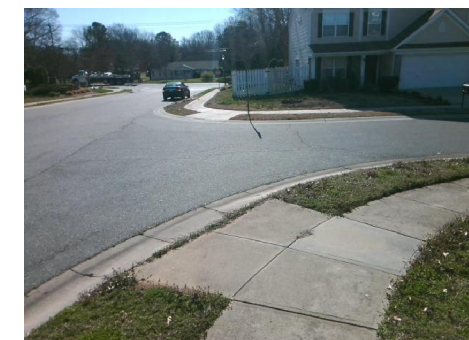
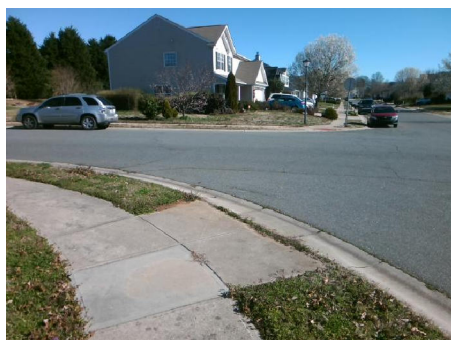
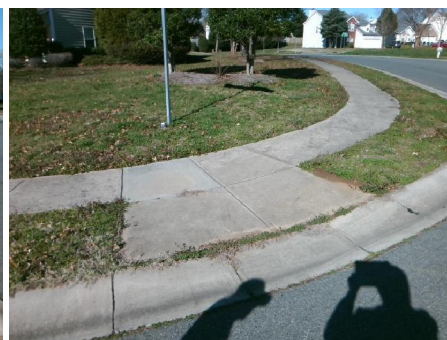
Not Found, R304.5.1, R304.5.3

Compliance	Description	Data	Compliance	Description	Data
N/A	Ramp Length (in)	46.0	Yes	Ramp Slope (%)	5.7
No	Ramp Width (in)	41.0	No	Ramp XSlope (%)	5.7
N/A	Flare Type LT	N/A	N/A	Flare Type RT	N/A
N/A	Flare Slope LT (%)	N/A	N/A	Flare Slope RT (%)	N/A
N/A	Flare Traversable LT?	N/A	N/A	Flare Traversable RT?	N/A
N/A	Landing Length (in)	N/A	N/A	DWS Provided?	N/A
N/A	Landing Width (in)	N/A	N/A	DWS Contrast?	N/A
N/A	Landing Slope (%)	N/A	N/A	DWS Length (in)	N/A
N/A	Landing X Slope (%)	N/A	N/A	DWS Full Width?	N/A
N/A	Landing Curb? (Y/N)	N/A	N/A	DWS Offset (in)	N/A
N/A	Shared Landing?	N/A			
N/A	Gutter Ponding?	N/A	N/A	Gutter Slope (%)	N/A
N/A	Gutter Lip Ht (in)	N/A	N/A	Gutter X Slope (%)	N/A
N/A	Painted X Walk1?	No	N/A	Painted X Walk2?	No
	X Walk 1 Direction	To SE		X Walk 2 Direction	To NE
N/A	X Walk 1 Width (in)	N/A	N/A	X Walk 2 Width (in)	N/A
	X Walk 1 Slope (%)	3.7		X Walk 2 Slope (%)	2.2
	X Walk 1 X Slope (%)	2.0		X Walk 2 X Slope (%)	4.0

N/A	Ramp inside XWalk1?	N/A	N/A	Ramp inside XWalk2?	N/A
	Road Slope (%)	5.1	N/A	Clear Space?	N/A
	Road X Slope (%)	1.2	N/A	Clear Space to XWalk (in)	N/A
N/A	Any Obstructions?	N/A	N/A	Storm Grate/Utility Hazard?	N/A
	Obstruction Type			Storm Grate/Utility Type	
		N/A			N/A
			Yes	Surface Condition? (G/P)	Good

Possible Solutions:

Remove & Replace Curb Ramp With Two New Directional Ramps or Equivalent.
