Access Compliance Report

Public Rights-of-Way

(Curb Ramps)

Intersection ID: 18963	Main Street: GROVER_RD	Cross Street: SOUTH_BV	Location: SW
ADA ID: B8E5CA5A9A35	Ramp Type: Perp	Initial Pass/Fail: Fail	Overall Compliance: No
Severity Score: 13.75			
Codes/Mitigation Info/Possible Solution		Field Measurements/Component Compliance

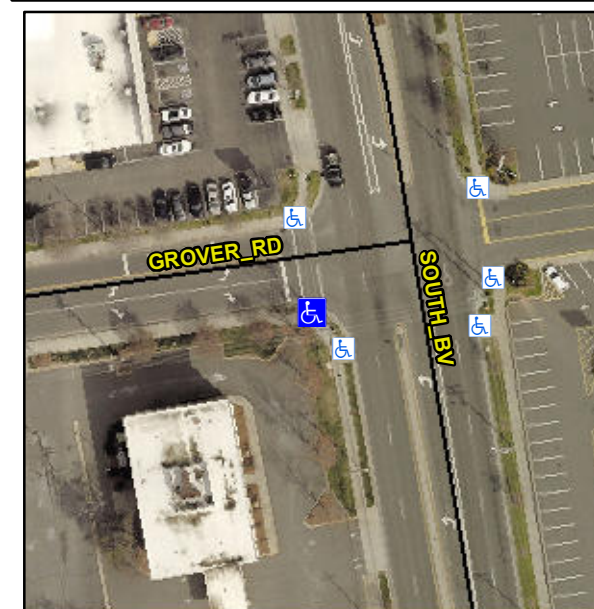
Not Found, R304.2.2, R304.5.3

Compliance	Description	Data	Compliance	Description	Data
N/A	Ramp Length (in)	47.5	No	Ramp Slope (%)	10.0
Yes	Ramp Width (in)	70.0	No	Ramp XSlope (%)	3.3
N/A	Flare Type LT	N/A	N/A	Flare Type RT	N/A
N/A	Flare Slope LT (%)	N/A	N/A	Flare Slope RT (%)	N/A
N/A	Flare Traversable LT?	N/A	N/A	Flare Traversable RT?	N/A
N/A	Landing Length (in)	N/A	N/A	DWS Provided?	N/A
N/A	Landing Width (in)	N/A	N/A	DWS Contrast?	N/A
N/A	Landing Slope (%)	N/A	N/A	DWS Length (in)	N/A
N/A	Landing X Slope (%)	N/A	N/A	DWS Full Width?	N/A
N/A	Landing Curb? (Y/N)	N/A	N/A	DWS Offset (in)	N/A
N/A	Shared Landing?	N/A			
N/A	Gutter Ponding?	N/A	N/A	Gutter Slope (%)	N/A
N/A	Gutter Lip Ht (in)	N/A	N/A	Gutter X Slope (%)	N/A
N/A	Painted X Walk1?	Yes	N/A	Painted X Walk2?	N/A
	X Walk 1 Direction	To N		X Walk 2 Direction	N/A
N/A	X Walk 1 Width (in)	110.0	N/A	X Walk 2 Width (in)	N/A
	X Walk 1 Slope (%)	2.2		X Walk 2 Slope (%)	N/A
	X Walk 1 X Slope (%)	2.8		X Walk 2 X Slope (%)	N/A

N/A	Ramp inside XWalk1?	Yes	N/A	Ramp inside XWalk2?	N/A
	Road Slope (%)	N/A	N/A	Clear Space?	N/A
	Road X Slope (%)	N/A	N/A	Clear Space to XWalk (in)	N/A
N/A	Any Obstructions?	N/A	N/A	Storm Grate/Utility Hazard?	N/A
	Obstruction Type			Storm Grate/Utility Type	
		N/A			N/A
		Yes		Surface Condition? (G/P)	Good

Remove & Replace Entire Ramp.
