Access Compliance Report

Public Rights-of-Way

(Curb Ramps)

Intersection ID: 26143	Main Street: CARMEL_RD	Cross Street: SEVILLA_CT	Location: NW
ADA ID: B8E6D173A608	Ramp Type: PerpDiag	Initial Pass/Fail: Fail	Overall Compliance: No
		Severity Score: 25

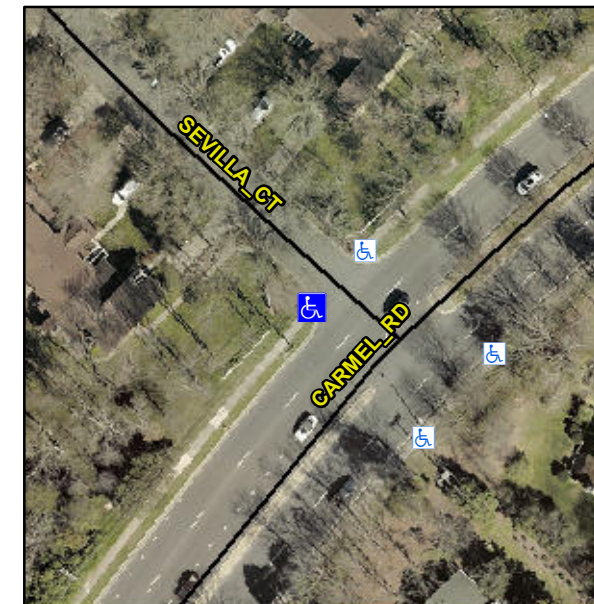
Not Found, R304.5.3

Compliance	Description	Data	Compliance	Description	Data
N/A	Ramp Length (in)	72.0	Yes	Ramp Slope (%)	6.5
Yes	Ramp Width (in)	48.0	No	Ramp XSlope (%)	7.3
N/A	Flare Type LT	N/A	N/A	Flare Type RT	N/A
N/A	Flare Slope LT (%)	N/A	N/A	Flare Slope RT (%)	N/A
N/A	Flare Traversable LT?	N/A	N/A	Flare Traversable RT?	N/A
N/A	Landing Length (in)	N/A	N/A	DWS Provided?	N/A
N/A	Landing Width (in)	N/A	N/A	DWS Contrast?	N/A
N/A	Landing Slope (%)	N/A	N/A	DWS Length (in)	N/A
N/A	Landing X Slope (%)	N/A	N/A	DWS Full Width?	N/A
N/A	Landing Curb? (Y/N)	N/A	N/A	DWS Offset (in)	N/A
N/A	Shared Landing?	N/A			
N/A	Gutter Ponding?	N/A	N/A	Gutter Slope (%)	N/A
N/A	Gutter Lip Ht (in)	N/A	N/A	Gutter X Slope (%)	N/A
N/A	Painted X Walk1?	No	N/A	Painted X Walk2?	No
	X Walk 1 Direction	To SE		X Walk 2 Direction	To NE
N/A	X Walk 1 Width (in)	N/A	N/A	X Walk 2 Width (in)	N/A
	X Walk 1 Slope (%)	4.4		X Walk 2 Slope (%)	3.3
	X Walk 1 X Slope (%)	1.0		X Walk 2 X Slope (%)	6.3

N/A	Ramp inside XWalk1?	N/A	N/A	Ramp inside XWalk2?	N/A
	Road Slope (%)	3.3	N/A	Clear Space?	N/A
	Road X Slope (%)	8.2	N/A	Clear Space to XWalk (in)	N/A
N/A	Any Obstructions?	N/A	N/A	Storm Grate/Utility Hazard?	N/A
	Obstruction Type			Storm Grate/Utility Type	
		N/A			N/A
			Yes	Surface Condition? (G/P)	Good

Remove & Replace Curb Ramp With Two New Directional Ramps or Equivalent.
