# Access Compliance Report

## Public Rights-of-Way

### (Curb Ramps)

Intersection ID: 7329	Main Street: DAWNSHIRE_AV	Cross Street: NORTHCLIFF_DR	Location:	N
ADA ID: B8E8570EB687	Ramp Type: Perp	Initial Pass/Fail: Fail	Overall Compliance: No	Severity Score: 25

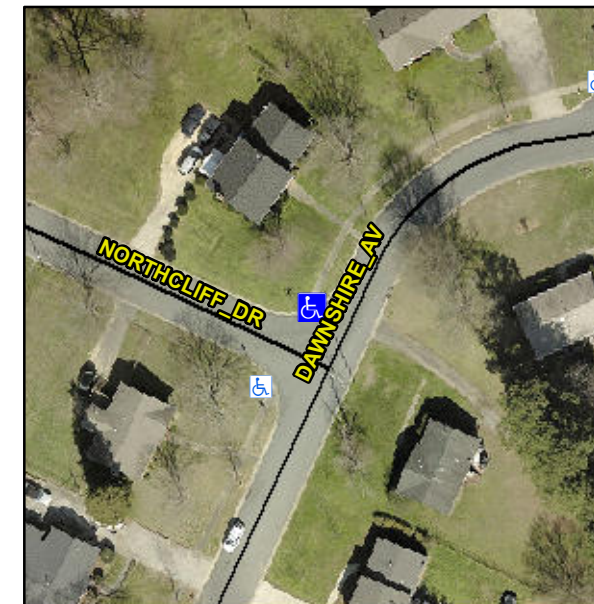
Compliance	Description	Data	Compliance	Description	Data
N/A	Ramp Length (in)	43.0	Yes	Ramp Slope (%)	8.2
Yes	Ramp Width (in)	48.0	No	Ramp XSlope (%)	7.1
N/A	Flare Type LT	N/A	N/A	Flare Type RT	N/A
N/A	Flare Slope LT (%)	N/A	N/A	Flare Slope RT (%)	N/A
N/A	Flare Traversable LT?	N/A	N/A	Flare Traversable RT?	N/A
N/A	Landing Length (in)	N/A	N/A	DWS Provided?	N/A
N/A	Landing Width (in)	N/A	N/A	DWS Contrast?	N/A
N/A	Landing Slope (%)	N/A	N/A	DWS Length (in)	N/A
N/A	Landing X Slope (%)	N/A	N/A	DWS Full Width?	N/A
N/A	Landing Curb? (Y/N)	N/A	N/A	DWS Offset (in)	N/A
N/A	Shared Landing?	N/A			
N/A	Gutter Ponding?	N/A	N/A	Gutter Slope (%)	N/A
N/A	Gutter Lip Ht (in)	N/A	N/A	Gutter X Slope (%)	N/A
N/A	Painted X Walk1?	No	N/A	Painted X Walk2?	N/A
	X Walk 1 Direction	To SW		X Walk 2 Direction	N/A
N/A	X Walk 1 Width (in)	N/A	N/A	X Walk 2 Width (in)	N/A
	X Walk 1 Slope (%)	2.0		X Walk 2 Slope (%)	N/A
	X Walk 1 X Slope (%)	8.5		X Walk 2 X Slope (%)	N/A

N/A	Ramp inside XWalk1?	N/A	N/A	Ramp inside XWalk2?	N/A
	Road Slope (%)	N/A	N/A	Clear Space?	N/A
	Road X Slope (%)	N/A	N/A	Clear Space to XWalk (in)	N/A
N/A	Any Obstructions?	N/A	N/A	Storm Grate/Utility Hazard?	N/A
	Obstruction Type			Storm Grate/Utility Type	
		N/A			N/A
			Yes	Surface Condition? (G/P)	Good

Possible Solutions:

**Remove & Replace Entire Ramp.**

**Not Found, R304.5.3**
