Access Compliance Report

Public Rights-of-Way

(Curb Ramps)

Intersection ID: 15439	Main Street: TROTTERS RIDGE RD	Cross Street: JEWELFLOWER RD	Location: SW
ADA ID: B8F2CEB02B8E	Ramp Type: PerpDiag	Initial Pass/Fail: Fail	Overall Compliance: No
Severity Score: 33.75			
Codes/Mitigation Info/Possible Solution		Field Measurements/Component Compliance

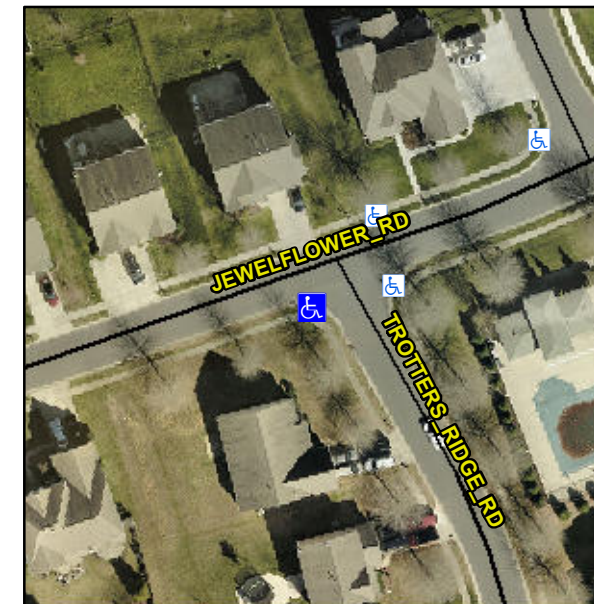
Compliance	Description	Data	Compliance	Description	Data
N/A	Ramp Length (in)	49.0	No	Ramp Slope (%)	9.2
No	Ramp Width (in)	47.0	No	Ramp XSlope (%)	5.1
N/A	Flare Type LT	N/A	N/A	Flare Type RT	N/A
N/A	Flare Slope LT (%)	N/A	N/A	Flare Slope RT (%)	N/A
N/A	Flare Traversable LT?	N/A	N/A	Flare Traversable RT?	N/A
N/A	Landing Length (in)	N/A	N/A	DWS Provided?	N/A
N/A	Landing Width (in)	N/A	N/A	DWS Contrast?	N/A
N/A	Landing Slope (%)	N/A	N/A	DWS Length (in)	N/A
N/A	Landing X Slope (%)	N/A	N/A	DWS Full Width?	N/A
N/A	Landing Curb? (Y/N)	N/A	N/A	DWS Offset (in)	N/A
N/A	Shared Landing?	N/A			
N/A	Gutter Ponding?	N/A	N/A	Gutter Slope (%)	N/A
N/A	Gutter Lip Ht (in)	N/A	N/A	Gutter X Slope (%)	N/A
N/A	Painted X Walk1?	No	N/A	Painted X Walk2?	No
	X Walk 1 Direction	To E		X Walk 2 Direction	To N
N/A	X Walk 1 Width (in)	N/A	N/A	X Walk 2 Width (in)	N/A
	X Walk 1 Slope (%)	2.7		X Walk 2 Slope (%)	2.1
	X Walk 1 X Slope (%)	2.2		X Walk 2 X Slope (%)	5.2

N/A	Ramp inside XWalk1?	N/A	N/A	Ramp inside XWalk2?	N/A
	Road Slope (%)	5.2	N/A	Clear Space?	N/A
	Road X Slope (%)	3.3	N/A	Clear Space to XWalk (in)	N/A
N/A	Any Obstructions?	N/A	N/A	Storm Grate/Utility Hazard?	N/A
	Obstruction Type			Storm Grate/Utility Type	
		N/A			N/A
			Yes	Surface Condition? (G/P)	Good

Remove & Replace Curb Ramp With Two New Directional Ramps or Equivalent.

R304.5.1, R304.2.2, R304.5.3
