Access Compliance Report

Public Rights-of-Way

(Curb Ramps)

Intersection ID: 24028	Main Street: EDENBRIDGE_LN	Cross Street: REA_RD	Location: SW
ADA ID: B8F4A92208C1	Ramp Type: PerpDiag	Initial Pass/Fail: Fail	Overall Compliance: No
		Severity Score: 12.5

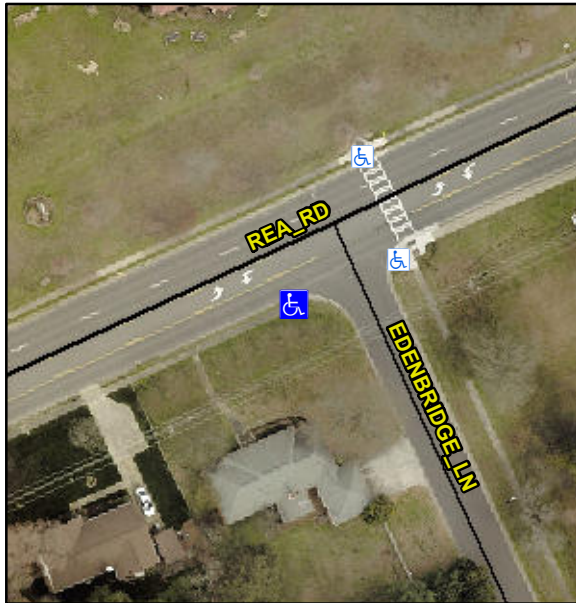
Compliance	Description	Data	Compliance	Description	Data
N/A	Ramp Length (in)	36.0	No	Ramp Slope (%)	8.6
Yes	Ramp Width (in)	48.0	Yes	Ramp XSlope (%)	1.3
N/A	Flare Type LT	N/A	N/A	Flare Type RT	N/A
N/A	Flare Slope LT (%)	N/A	N/A	Flare Slope RT (%)	N/A
N/A	Flare Traversable LT?	N/A	N/A	Flare Traversable RT?	N/A
N/A	Landing Length (in)	N/A	N/A	DWS Provided?	N/A
N/A	Landing Width (in)	N/A	N/A	DWS Contrast?	N/A
N/A	Landing Slope (%)	N/A	N/A	DWS Length (in)	N/A
N/A	Landing X Slope (%)	N/A	N/A	DWS Full Width?	N/A
N/A	Landing Curb? (Y/N)	N/A	N/A	DWS Offset (in)	N/A
N/A	Shared Landing?	N/A			
N/A	Gutter Ponding?	N/A	N/A	Gutter Slope (%)	N/A
N/A	Gutter Lip Ht (in)	N/A	N/A	Gutter X Slope (%)	N/A
N/A	Painted X Walk1?	No	N/A	Painted X Walk2?	No
	X Walk 1 Direction	To NE		X Walk 2 Direction	To NW
N/A	X Walk 1 Width (in)	N/A	N/A	X Walk 2 Width (in)	N/A
	X Walk 1 Slope (%)	2.4		X Walk 2 Slope (%)	2.4
	X Walk 1 X Slope (%)	3.8		X Walk 2 X Slope (%)	3.1

N/A	Ramp inside XWalk1?	N/A	N/A	Ramp inside XWalk2?	N/A
	Road Slope (%)	2.0	N/A	Clear Space?	N/A
	Road X Slope (%)	3.0	N/A	Clear Space to XWalk (in)	N/A
N/A	Any Obstructions?	N/A	N/A	Storm Grate/Utility Hazard?	N/A
	Obstruction Type			Storm Grate/Utility Type	
		N/A			N/A
			Yes	Surface Condition? (G/P)	Good

Remove & Replace Curb Ramp With Two New Directional Ramps or Equivalent.
