Access Compliance Report

Public Rights-of-Way

(Curb Ramps)

Intersection ID: 32250	Main Street: DARCY_HOPKINS_DR	Cross Street: DENNINGTON_GROVE_LN	Location: W
ADA ID: B8F8B539673C	Ramp Type: PerpDiag	Initial Pass/Fail: Fail	Overall Compliance: No
Severity Score: 22.5			
Codes/Mitigation Info/Possible Solution		Field Measurements/Component Compliance

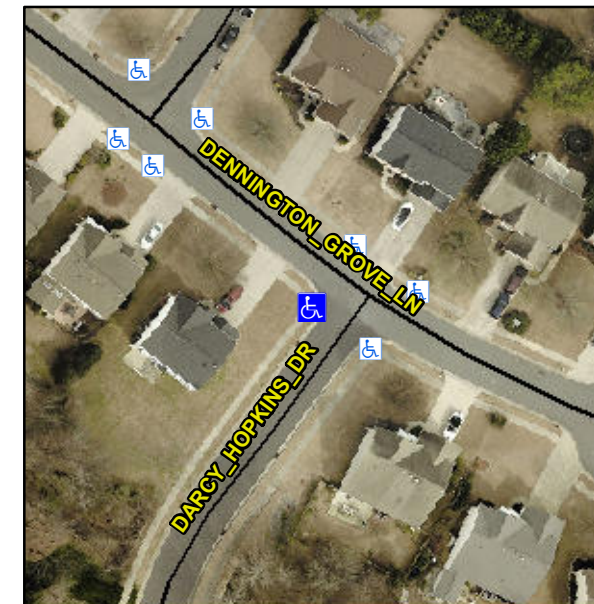
Not Found, R304.5.1, R304.2.2, R304.5.3

Compliance	Description	Data	Compliance	Description	Data
N/A	Ramp Length (in)	99.0	No	Ramp Slope (%)	8.5
No	Ramp Width (in)	46.0	No	Ramp XSlope (%)	2.6
N/A	Flare Type LT	N/A	N/A	Flare Type RT	N/A
N/A	Flare Slope LT (%)	N/A	N/A	Flare Slope RT (%)	N/A
N/A	Flare Traversable LT?	N/A	N/A	Flare Traversable RT?	N/A
N/A	Landing Length (in)	N/A	N/A	DWS Provided?	N/A
N/A	Landing Width (in)	N/A	N/A	DWS Contrast?	N/A
N/A	Landing Slope (%)	N/A	N/A	DWS Length (in)	N/A
N/A	Landing X Slope (%)	N/A	N/A	DWS Full Width?	N/A
N/A	Landing Curb? (Y/N)	N/A	N/A	DWS Offset (in)	N/A
N/A	Shared Landing?	N/A			
N/A	Gutter Ponding?	N/A	N/A	Gutter Slope (%)	N/A
N/A	Gutter Lip Ht (in)	N/A	N/A	Gutter X Slope (%)	N/A
N/A	Painted X Walk1?	No	N/A	Painted X Walk2?	No
	X Walk 1 Direction	To SE		X Walk 2 Direction	To NE
N/A	X Walk 1 Width (in)	N/A	N/A	X Walk 2 Width (in)	N/A
	X Walk 1 Slope (%)	0.0		X Walk 2 Slope (%)	2.1
	X Walk 1 X Slope (%)	3.3		X Walk 2 X Slope (%)	0.4

N/A	Ramp inside XWalk1?	N/A	N/A	Ramp inside XWalk2?	N/A
	Road Slope (%)	1.5	N/A	Clear Space?	N/A
	Road X Slope (%)	1.8	N/A	Clear Space to XWalk (in)	N/A
N/A	Any Obstructions?	N/A	N/A	Storm Grate/Utility Hazard?	N/A
	Obstruction Type			Storm Grate/Utility Type	
		N/A			N/A
			Yes	Surface Condition? (G/P)	Good

Remove & Replace Curb Ramp With Two New Directional Ramps or Equivalent.
