# Access Compliance Report

## Public Rights-of-Way

### (Curb Ramps)

Intersection ID: 13149	Main Street: CENTRAL_AV	Cross Street: THE_PLAZA	Location: SW
ADA ID: B8FCE7CAC410	Ramp Type: Perp	Initial Pass/Fail: Fail	Overall Compliance: No
Severity Score: 43.75			
Codes/Mitigation Info/Possible Solution		Field Measurements/Component Compliance

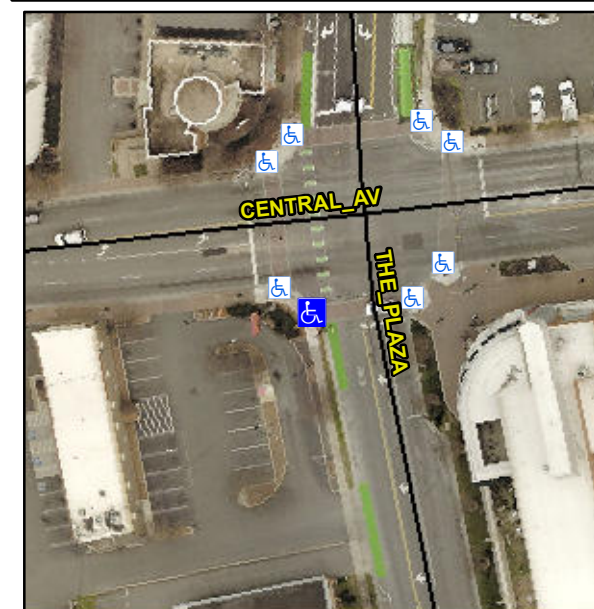
**Not Found, R304.5.1, R304.2.2, R304.5.3**

Compliance	Description	Data	Compliance	Description	Data
N/A	Ramp Length (in)	65.0	No	Ramp Slope (%)	18.6
No	Ramp Width (in)	33.0	No	Ramp XSlope (%)	2.7
N/A	Flare Type LT	N/A	N/A	Flare Type RT	N/A
N/A	Flare Slope LT (%)	N/A	N/A	Flare Slope RT (%)	N/A
N/A	Flare Traversable LT?	N/A	N/A	Flare Traversable RT?	N/A
N/A	Landing Length (in)	N/A	N/A	DWS Provided?	N/A
N/A	Landing Width (in)	N/A	N/A	DWS Contrast?	N/A
N/A	Landing Slope (%)	N/A	N/A	DWS Length (in)	N/A
N/A	Landing X Slope (%)	N/A	N/A	DWS Full Width?	N/A
N/A	Landing Curb? (Y/N)	N/A	N/A	DWS Offset (in)	N/A
N/A	Shared Landing?	N/A			
N/A	Gutter Ponding?	N/A	N/A	Gutter Slope (%)	N/A
N/A	Gutter Lip Ht (in)	N/A	N/A	Gutter X Slope (%)	N/A
N/A	Painted X Walk1?	Yes	N/A	Painted X Walk2?	N/A
	X Walk 1 Direction	To E		X Walk 2 Direction	N/A
N/A	X Walk 1 Width (in)	96.0	N/A	X Walk 2 Width (in)	N/A
	X Walk 1 Slope (%)	3.4		X Walk 2 Slope (%)	N/A
	X Walk 1 X Slope (%)	0.2		X Walk 2 X Slope (%)	N/A

N/A	Ramp inside XWalk1?	Yes	N/A	Ramp inside XWalk2?	N/A
	Road Slope (%)	N/A	N/A	Clear Space?	N/A
	Road X Slope (%)	N/A	N/A	Clear Space to XWalk (in)	N/A
N/A	Any Obstructions?	N/A	N/A	Storm Grate/Utility Hazard?	N/A
	Obstruction Type			Storm Grate/Utility Type	
		N/A			N/A
		Yes		Surface Condition? (G/P)	Good

Possible Solutions:

**Remove & Replace Entire Ramp.**
