# Access Compliance Report

## Public Rights-of-Way

### (Curb Ramps)

Intersection ID: 13870	Main Street: LAMAR_AV	Cross Street: PARK_DR	Location: S
ADA ID: B90216C89DA3	Ramp Type: PerpDiag	Initial Pass/Fail: Fail	Overall Compliance: No
Severity Score: 26.25			
Codes/Mitigation Info/Possible Solution		Field Measurements/Component Compliance

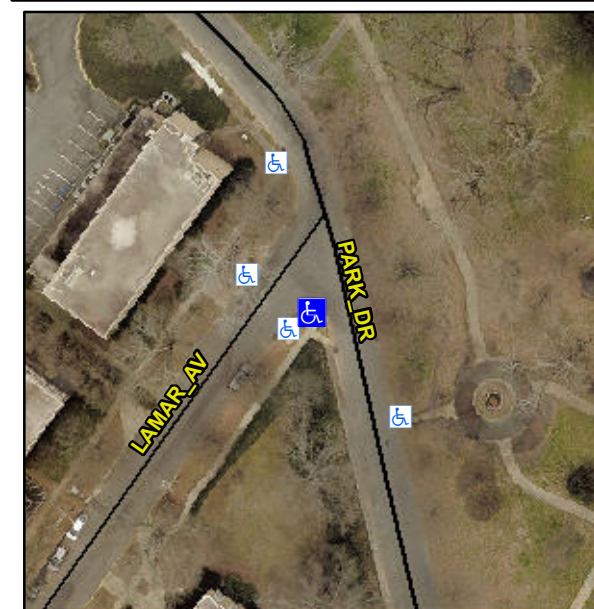
Compliance	Description	Data	Compliance	Description	Data
N/A	Ramp Length (in)	88.0	No	Ramp Slope (%)	14.5
Yes	Ramp Width (in)	62.0	No	Ramp XSlope (%)	3.9
N/A	Flare Type LT	N/A	N/A	Flare Type RT	N/A
N/A	Flare Slope LT (%)	N/A	N/A	Flare Slope RT (%)	N/A
N/A	Flare Traversable LT?	N/A	N/A	Flare Traversable RT?	N/A
N/A	Landing Length (in)	N/A	N/A	DWS Provided?	N/A
N/A	Landing Width (in)	N/A	N/A	DWS Contrast?	N/A
N/A	Landing Slope (%)	N/A	N/A	DWS Length (in)	N/A
N/A	Landing X Slope (%)	N/A	N/A	DWS Full Width?	N/A
N/A	Landing Curb? (Y/N)	N/A	N/A	DWS Offset (in)	N/A
N/A	Shared Landing?	N/A			
N/A	Gutter Ponding?	N/A	N/A	Gutter Slope (%)	N/A
N/A	Gutter Lip Ht (in)	N/A	N/A	Gutter X Slope (%)	N/A
N/A	Painted X Walk1?	No	N/A	Painted X Walk2?	No
	X Walk 1 Direction	To E		X Walk 2 Direction	To N
N/A	X Walk 1 Width (in)	N/A	N/A	X Walk 2 Width (in)	N/A
	X Walk 1 Slope (%)	1.9		X Walk 2 Slope (%)	2.0
	X Walk 1 X Slope (%)	3.3		X Walk 2 X Slope (%)	2.7

N/A	Ramp inside XWalk1?	N/A	N/A	Ramp inside XWalk2?	N/A
	Road Slope (%)	4.5	N/A	Clear Space?	N/A
	Road X Slope (%)	0.2	N/A	Clear Space to XWalk (in)	N/A
N/A	Any Obstructions?	N/A	N/A	Storm Grate/Utility Hazard?	N/A
	Obstruction Type			Storm Grate/Utility Type	
		N/A			N/A
		Yes		Surface Condition? (G/P)	Good

Possible Solutions:

**Remove & Replace Curb Ramp With Two New Directional Ramps or Equivalent.**

**R304.2.2, R304.5.3**
