## **Access Compliance Report Public Rights-of-Way** (Curb Ramps)

Intersection ID: 14078 Main Street: EAST BV Cross Street: SOUTH\_BV Location: SW ADA ID: B902CA17A1CF Ramp Type: Perp Initial Pass/Fail: Fail **Overall Compliance: No Severity Score:** 10

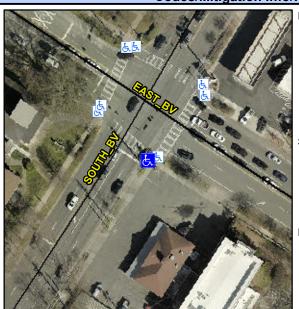
| Possible Solutions: | Compliance Description |
|---|---|
| Not Found, R304.5.1 | N/A Gutter Lip Ht (in) |

| N/A | Ramp Length (in) | 39.0 | Yes | Ramp Slope (%) | 5.2 |
|---|---|---|---|---|---|
| No | Ramp Width (in) | 46.5 | Yes | Ramp XSlope (%) | 2.2 |

| Possible Solutions: | Compliance Description |
|---|---|
| Remove & Replace Entire Ramp. | N/A Ramp Length (in) |

| PROW/ADA: | | | | N/A |
|---|---|---|---|---|
| Total Cost: | | \$ | 1850.00 | N/A |
