Access Compliance Report Public Rights-of-Way (Curb Ramps)

Intersection ID: 10033044 Main Street: NOLLEY_CT Cross Street: N/A Location: SE **Overall Compliance: No** ADA ID: B90DB878D1F4 Ramp Type: Perp Initial Pass/Fail: Fail **Severity Score:** 8.75

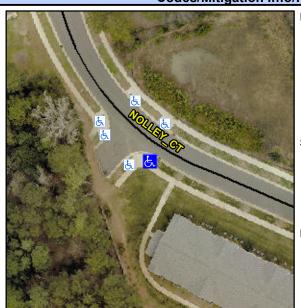
Comp	liance Description	Data		liance Description	Data
N/A	Ramp Length (in)	97.0	Yes Ramp Slope (%)		5.8
No	Ramp Width (in)	46.0	Yes Ramp XSlope (%)		0.4
N/A	Flare Type LT	N/A	N/A	Flare Type RT	N/A
N/A	Flare Slope LT (%)	N/A	N/A	Flare Slope RT (%)	N/A
N/A	Flare Traversable LT?	N/A	N/A	Flare Traversable RT?	N/A
N/A	Landing Length (in)	N/A	N/A DWS Provided?		N/A
N/A	Landing Width (in)	N/A	N/A DWS Contrast?		N/A
N/A	Landing Slope (%)	N/A	N/A	DWS Length (in)	N/A
N/A	Landing X Slope (%)	N/A	N/A	DWS Full Width?	N/A
N/A	Landing Curb? (Y/N)	N/A	N/A	DWS Offset (in)	N/A
N/A	Shared Landing?	N/A			
N/A	Gutter Ponding?	N/A	N/A	Gutter Slope (%)	N/A
N/A	Gutter Lip Ht (in)	N/A	N/A	Gutter X Slope (%)	N/A
N/A	Painted X Walk1?	No	N/A	Painted X Walk2?	N/A
	X Walk 1 Direction	To NE		X Walk 2 Direction	N/A
N/A	X Walk 1 Width (in)	N/A	N/A	X Walk 2 Width (in)	N/A
	X Walk 1 Slope (%)	0.4		X Walk 2 Slope (%)	N/A
	X Walk 1 X Slope (%)	2.4		X Walk 2 X Slope (%)	N/A

N/A	Ramp inside XWalk1?	N/A	N/A	Ramp inside XWalk2?	N/A
	Road Slope (%)	N/A	N/A	Clear Space?	N/A
	Road X Slope (%)	N/A	N/A	Clear Space to XWalk (in)	N/A
N/A	Any Obstructions?	N/A	N/A	Storm Grate/Utility Hazard?	N/A
	Obstruction Type			Storm Grate/Utility Type	
		N/A			N/A
			Yes	Surface Condition? (G/P)	Good

Possible Solutions:						
Remove & Replace Entire Ramp.						
Surveyor Notes:						
N/A						
N/A						
PROW/ADA:						
R304.5.1
